Home Inspection Report

Prepared for: Debbie Fees
Inspection #: 202504-60493
Inspection Address: 514 North Willey Street
Seaford DE 19973

Inspection Company: **Amerispec**
Office: 302-996-0405
Inspector: Clay Ballard Lic # DE H4-0010250

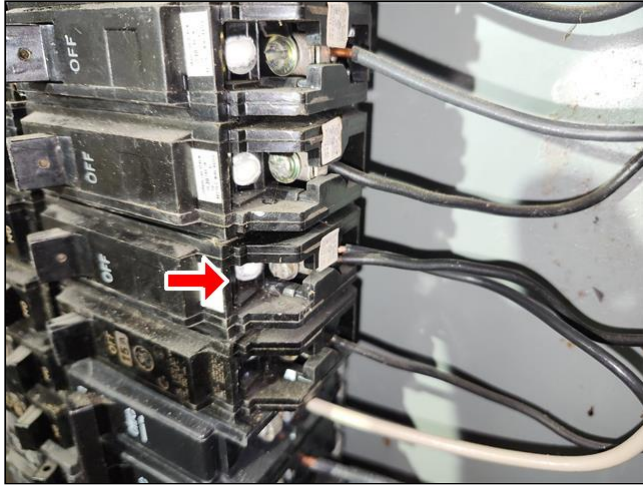
2.2 Item 1 (Picture)

Double tapping observed in the main panel. Double tapping (i.e. 2 wires on a single pole breaker) can add to the load of the affected circuit causing a possible overload and tripping breakers. Recommend repair / replacement as necessary.

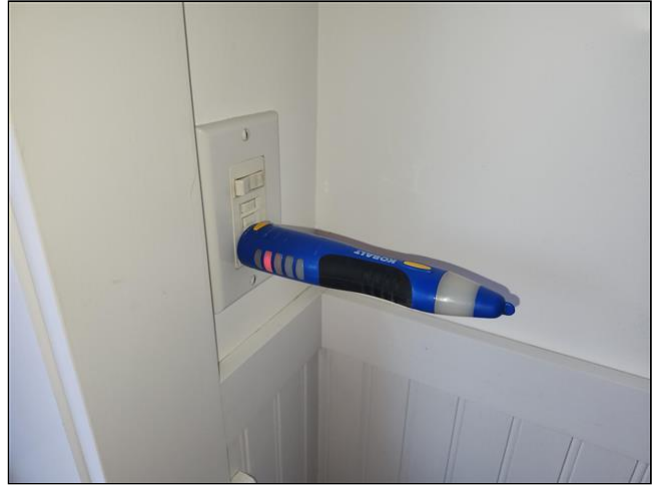
2.7 Item 2 (Picture) Bathroom

Ungrounded three prong outlets observed at multiple locations. It is recommended that these type receptacles be grounded, replaced with two prong receptacles, or protected on a GFCI receptacle as applicable. Recommend repairs / replacements as needed to ensure safety.

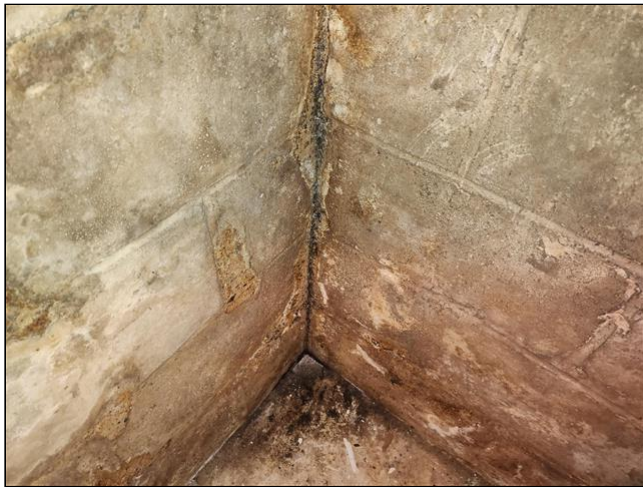
3.1 Item 1 (Picture)

Staining indicates prior water penetration throughout the basement. Staining on the the floor and moisture damaged legs also indicated prior water intrusion. Recommend repairs to eliminate water penetration

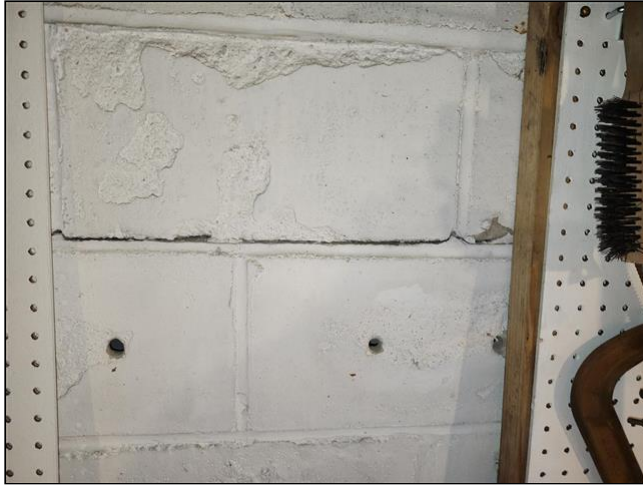
3.1 Item 3 (Picture)

Damaged / deteriorated mortar/cracking is present at: basement left side, re-pointing repairs are recommended to prevent water penetration and further mortar / brick deterioration.

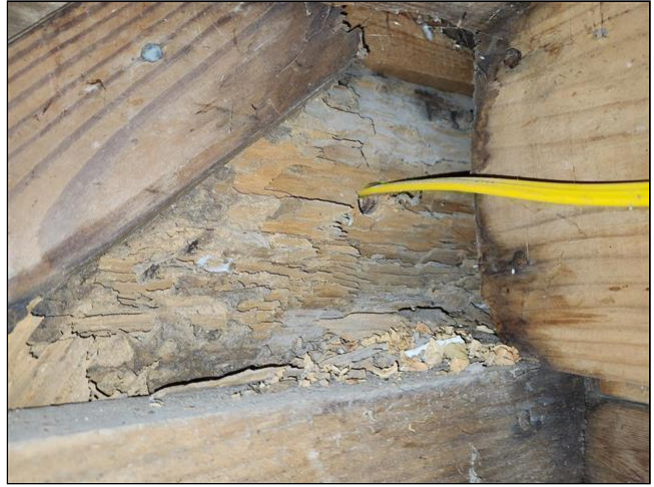
3.3 Item 2 (Picture)

Evidence of pest, wood destroying insect damage observed on the beam and sill plate in the basement. See Wood Destroying Insect Inspection Report.

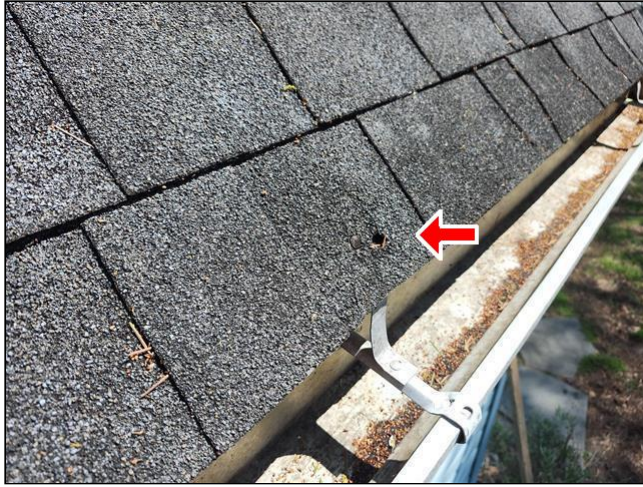
4.0 Item 1 (Picture)

Nails have penetrated through the shingles at rear of the home. Recommend repairs to correct this condition to prevent leakage.

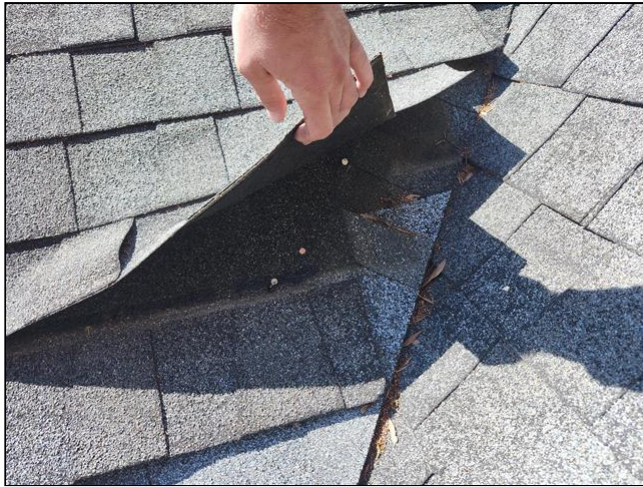
4.0 Item 2 (Picture)

Not all shingles are adhered in place (various locations) which may result in wind damage, recommend correcting to prevent leakage.

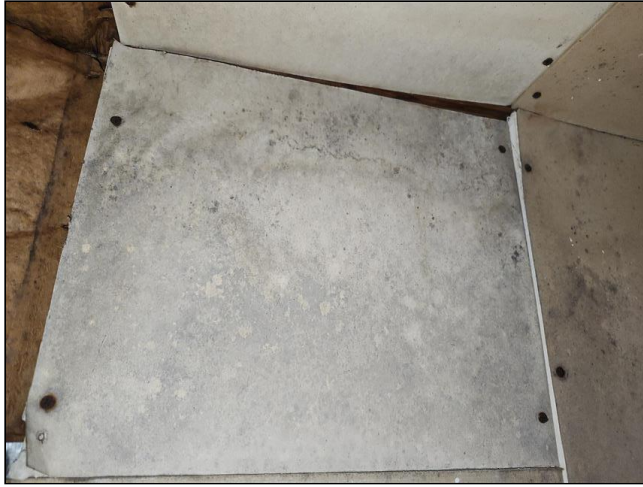
6.2 Item 1 (Picture)

Possible microbiological growth observed (walk-in section). Because certain types of microbiological spores may result in adverse health effects, it is strongly recommended that a microbiological inspection be performed by a qualified licensed professional and that corrective measures be taken to eliminate both microbiological growth and moisture related conditions.

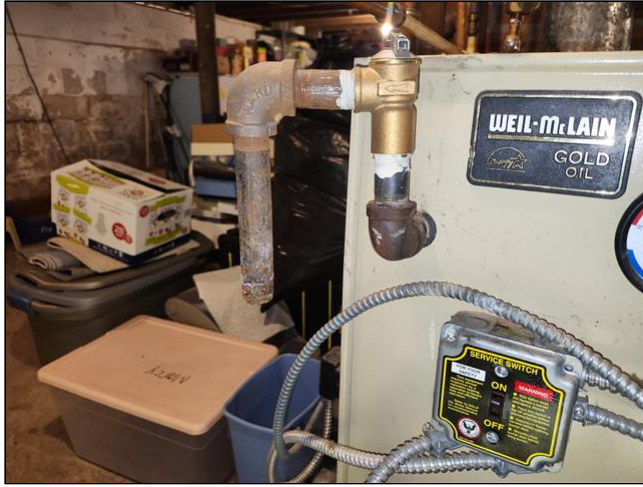
9.5 Item 1 (Picture)

The T&P (Test and Pressure) valve on water heater/boiler needs a 3/4 threaded pipe to extend within 6 inches of floor for safety. (PVC is not approved for hot water use). Recommend repair by a qualified plumber.

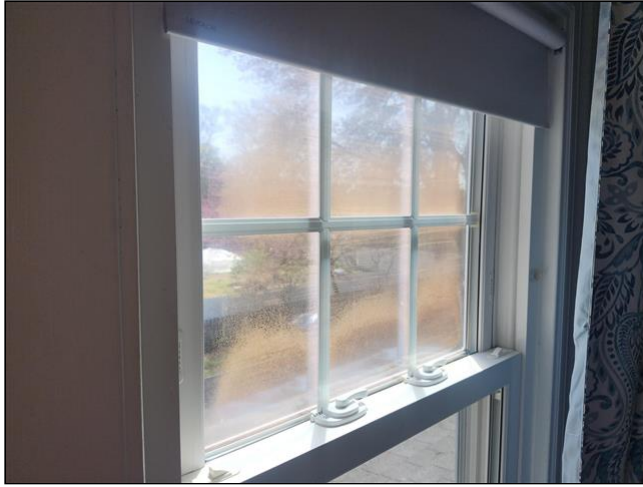
12.4 Item 1 (Picture)

Fog and condensation was noted in the double glazed insulated window panes in the 2nd floor bedroom (left side) and loft. This indicates a broken seal which not only reduces visibility but also reduces the insulating capability of this window. To restore visibility and regain the insulating capability, replacement of this window pane is required.

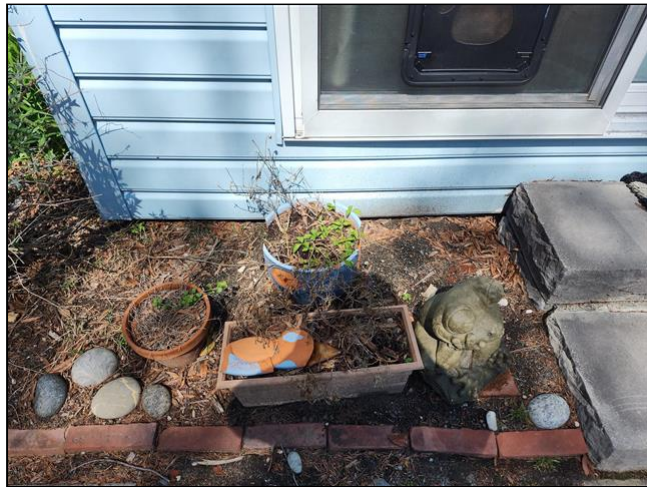
1.2 Item 1 (Picture)

Soil level is too high / in contact with siding. Grade should be 6 inches below any siding material to prevent moisture penetration, damage or pest activity. Recommend correcting, ensuring pitch is sloped to drain water away from the foundation.

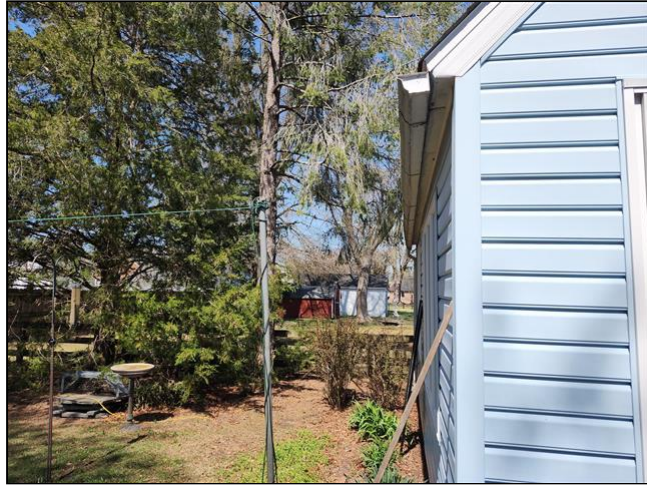
1.2 Item 2 (Picture)

Trimming and/or removal of vegetation / trees away from the structure is recommended as overgrowth can promote moisture damage and / or pest infiltration.

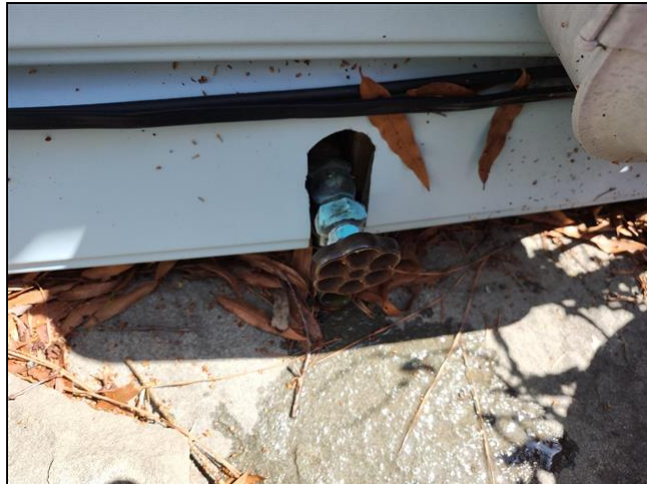
1.3 Item 1 (Picture)

Anti Siphon / Anti Freeze faucets are recommended. Poorly supported. They are designed to prevent water from flowing back into the plumbing system and freezing or cross contaminating the drinking supply. These may not have been required when the home was built.

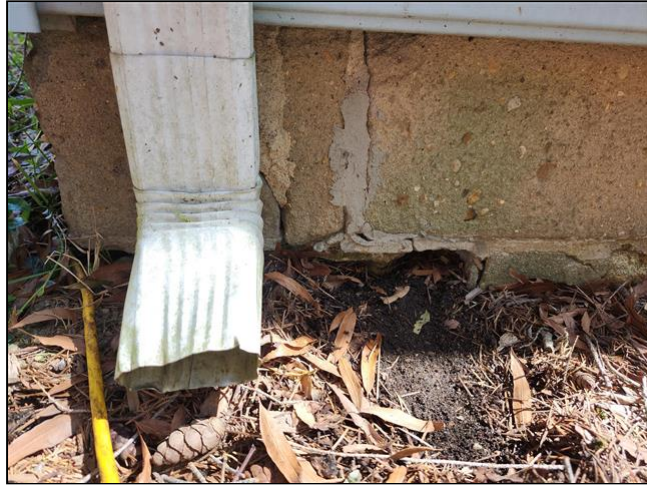
1.5 Item 1 (Picture)

Damaged / deteriorated mortar is present at various locations, re-pointing repairs are recommended to prevent water penetration and further mortar / brick deterioration.

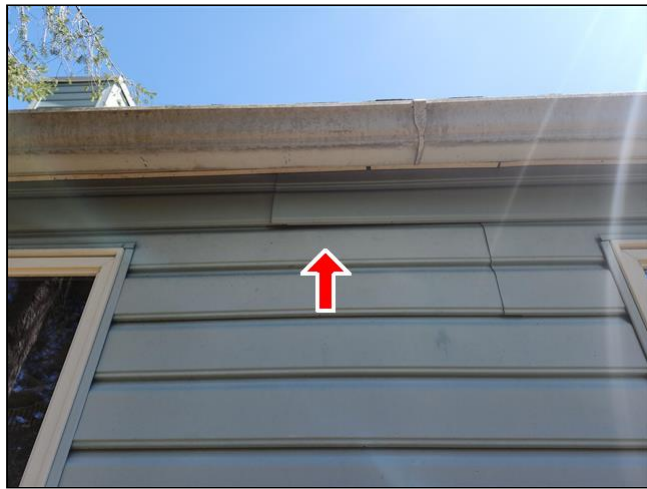
1.6 Item 1 (Picture)

Vinyl siding loosely attached at rear of the home. Recommend securing to prevent wind / water damage.

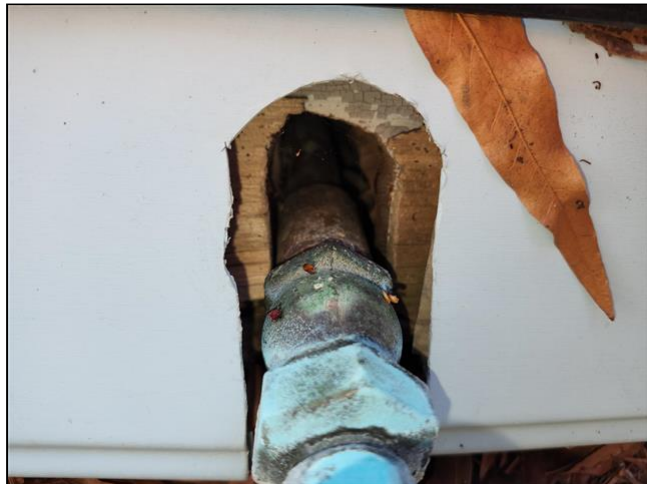
1.6 Item 2 (Picture)

Caulking gaps at service penetration and trim joints is recommended to prevent water penetration / damage.

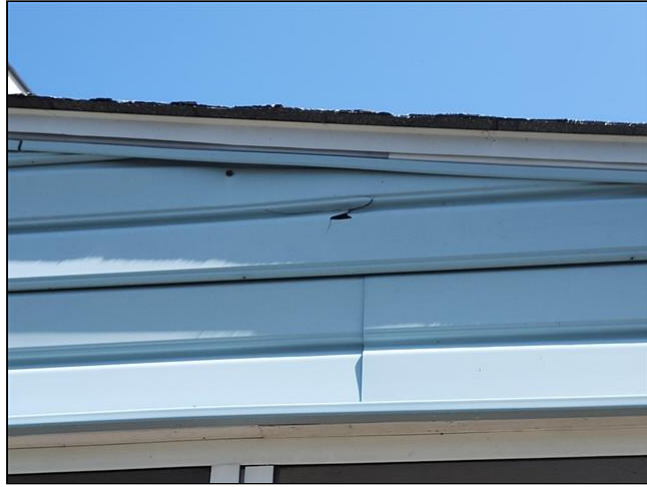
1.6 Item 3 (Picture)

Damaged and/or missing siding observed at: various locations.
Recommend repair / replacement as necessary.

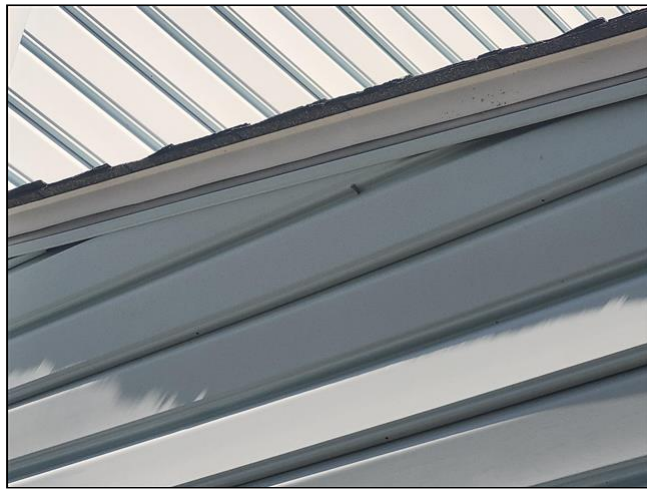
1.6 Item 4 (Picture)

Nail / Screw and holes observed at: various locations. Recommend patching, replacing or sealing to prevent moisture penetration.

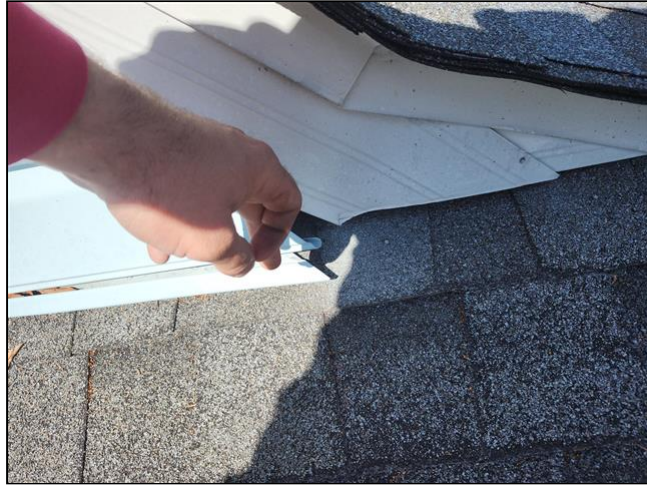
1.7 Item 1 (Picture)

Loose / missing trim pieces observed at front and left side of the home.

Recommend repair / replacement as necessary.

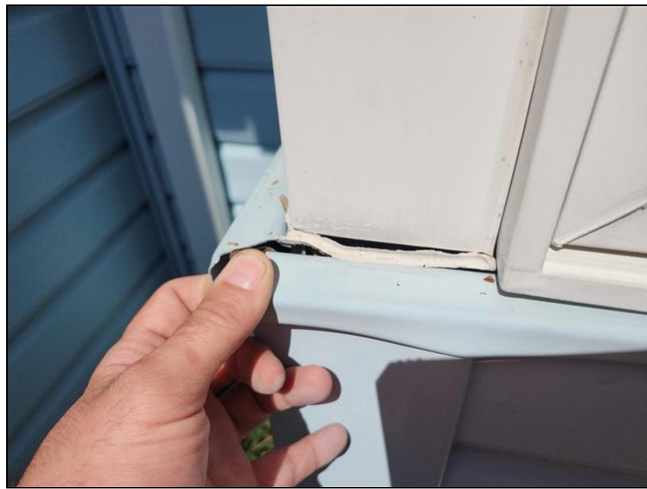
1.7 Item 2 (Picture)

Gaps / Openings present at rear left side of the home . Recommended correcting to prevent water / pest infiltration.

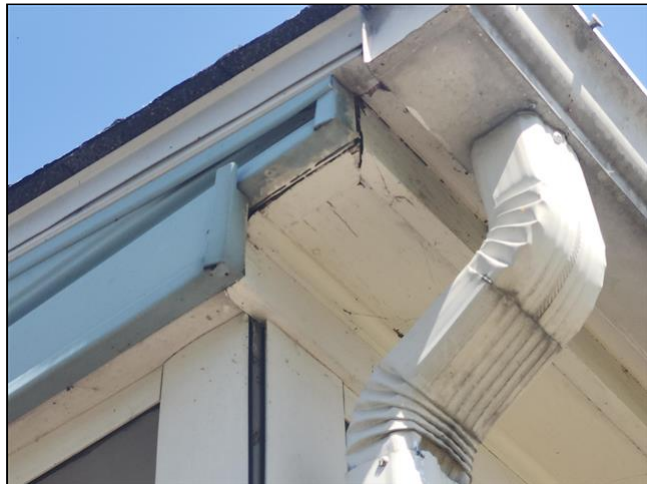
1.7 Item 3 (Picture)

Peeling paint observed at multiple locations; suggest scraping and painting as necessary as part of normal maintenance.

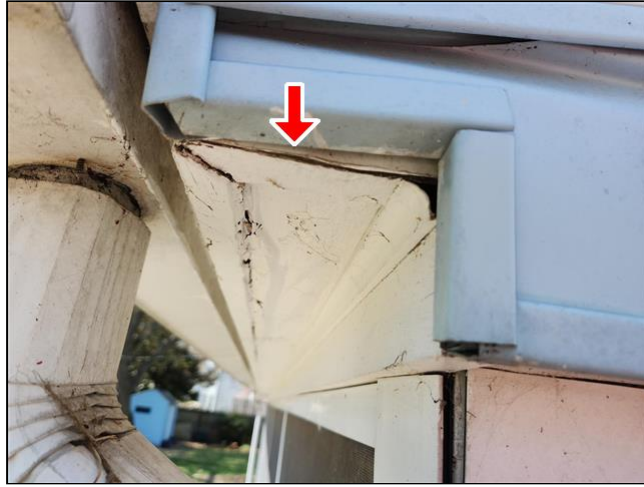
1.7 Item 4 (Picture)

Typical moisture damage observed at front left of the home. Recommend correcting to prevent further damage.

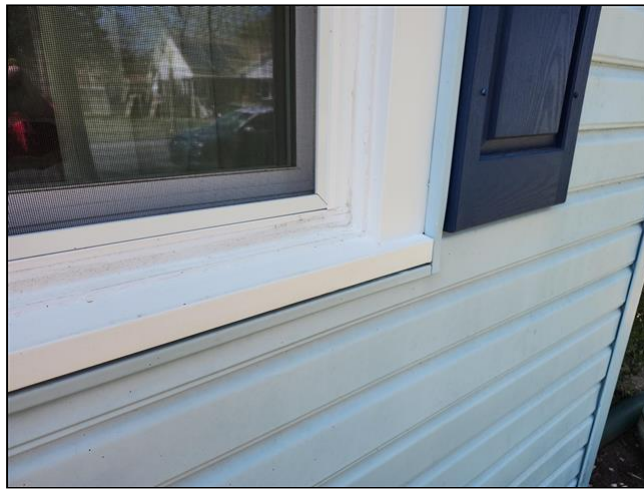
1.7 Item 5 (Picture)

This is an older home. Aluminum wrapped trim appears to have been installed over previously exposed wood trim. Hidden damage may exist.

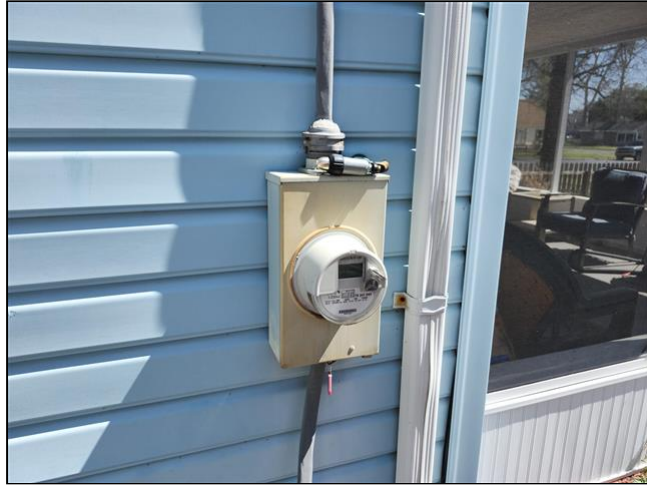
1.10 Item 1 (Picture)

The meter is loosely attached to the structure. Recommend utility company evaluate and correct as necessary.

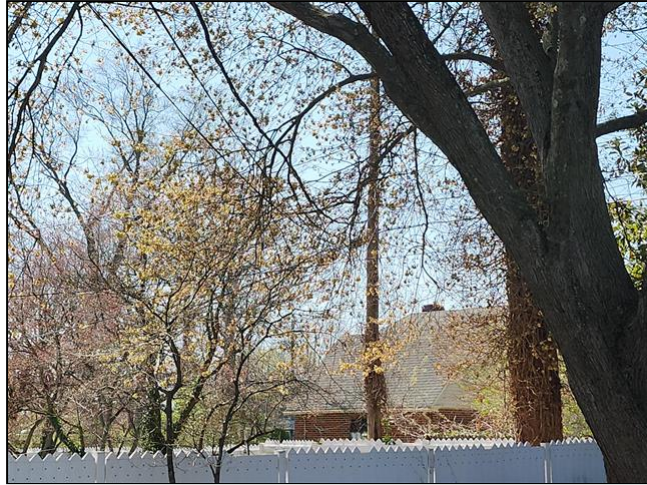
2.0 Item 1 (Picture)

Overhead service wire is in contact with tree(s) recommend contacting electric company to trim tree away from service wires.

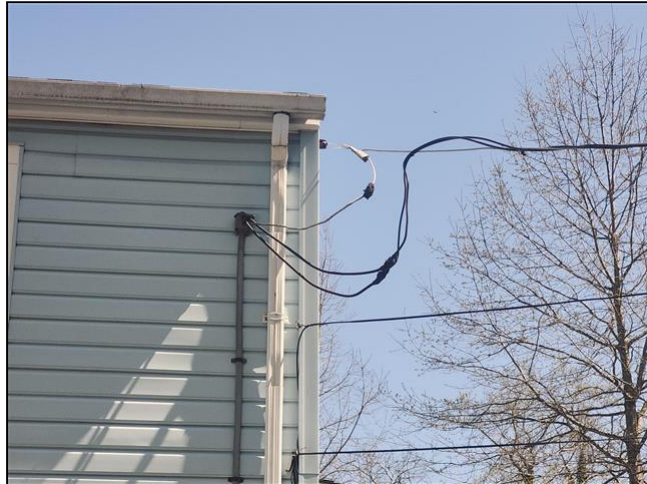
2.0 Item 2 (Picture)

The drip loop is not sufficient enough to allow rain water to drip off the service wiring. Drip loops are recommended in the main service wiring (below the weather head) so that rain water drips off the bottom of the service wiring instead of entering the weather head. Otherwise, water could flow down the wiring and into the weather head which could cause rusting and poor connections. Re-orienting of the service wiring is recommended to ensure rain water does not enter the weather head.

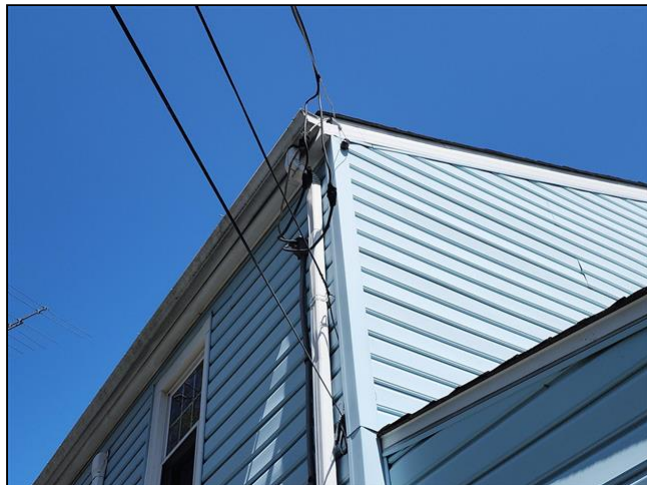
2.0 Item 3 (Picture)

Service wire is close to being in contact with metal / aluminum roof drainage system which is a potential shock hazard as voltage could transfer to the metal if the wire sheathing were to become damaged. Recommend correcting as needed.

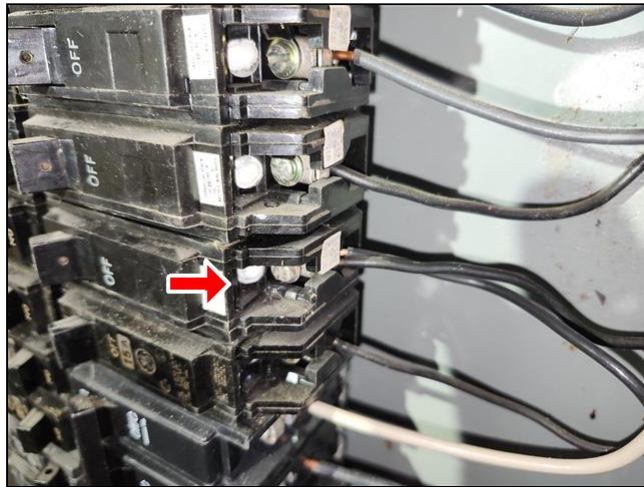
2.2 Item 1 (Picture)

Double tapping observed in the main panel. Double tapping (i.e. 2 wires on a single pole breaker) can add to the load of the affected circuit causing a possible overload and tripping breakers. Recommend repair / replacement as necessary.

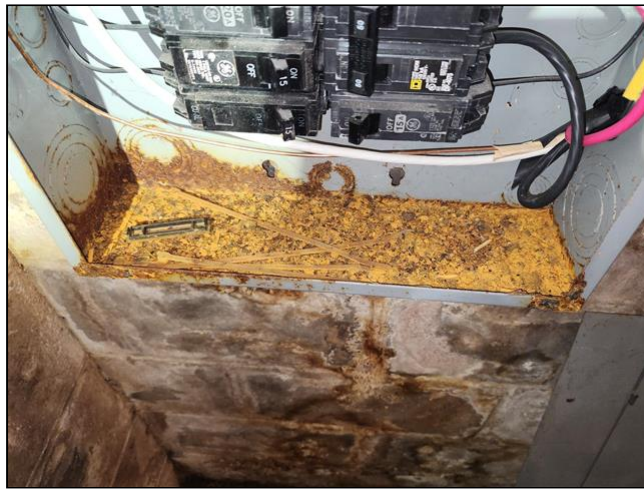
2.2 Item 2 (Picture)

Rust was observed in the main panel, which is a possible safety hazard. Recommend review by a qualified professional electrician for repair / replacement as necessary.

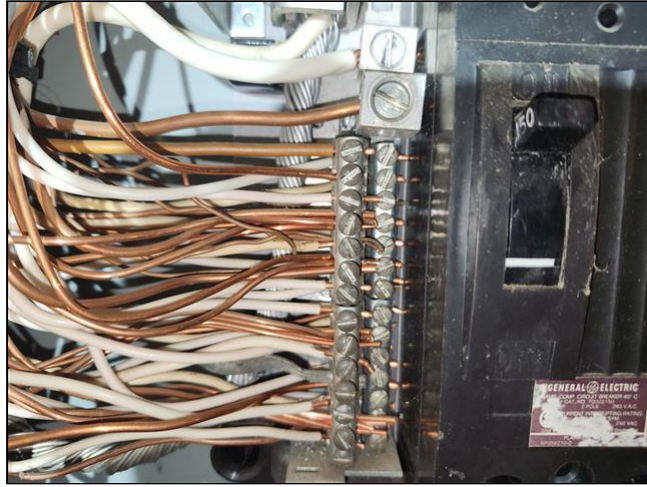
2.2 Item 4 (Picture)

Doubled up neutrals and grounds were observed in the main panel. The connection of a neutral and equipment-grounding conductor is no longer allowed by today's standards. One of the objectives of a correct arrangement of bonding jumpers, neutrals and equipment grounds is to allow circuit isolation while keeping the equipment grounding conductor still connected to the grounding electrode. A licensed electrician is recommended to review the panel and make all corrections necessary for safe and proper operation of the system.

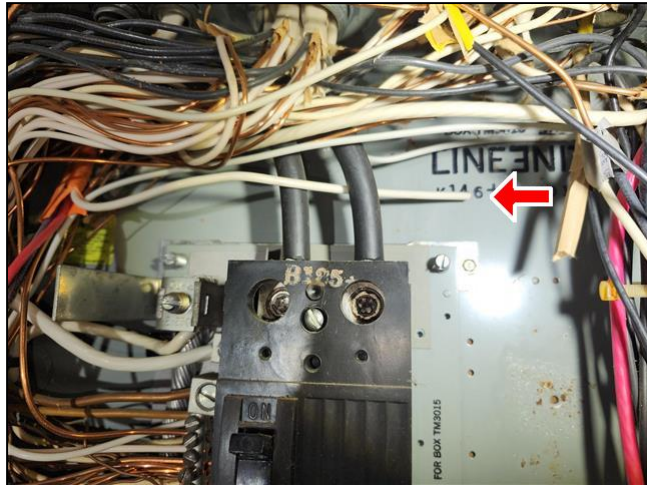
2.3 Item 1 (Picture)

Abandoned, uncapped wiring observed at main panel. Whenever an electric wire is cut it should be capped and encased in a covered junction box to prevent a potential shock / fire hazard in the event the line were to become live.

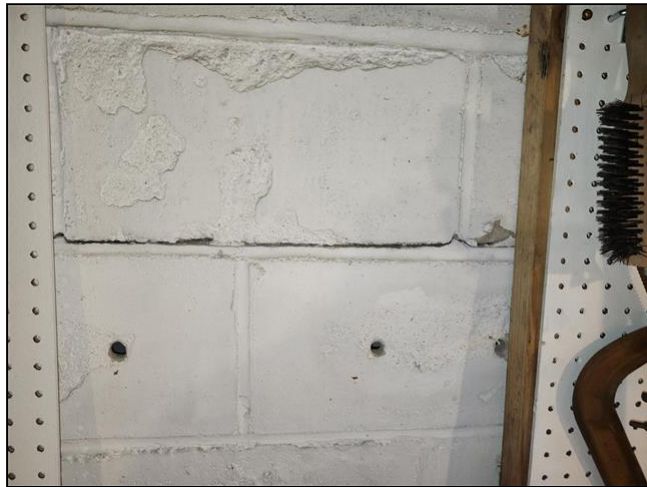
3.1 Item 3 (Picture)

Damaged / deteriorated mortar/cracking is present at: basement left side, re-pointing repairs are recommended to prevent water penetration and further mortar / brick deterioration.

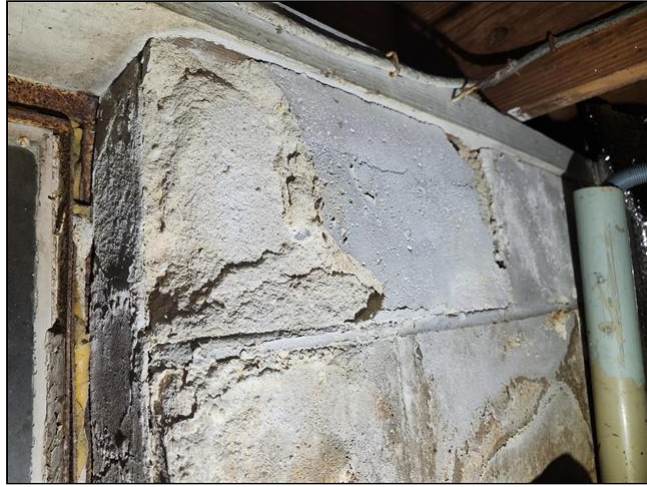
3.1 Item 4 (Picture)

Spalling block observed at: foundation wall. Recommend further review for repair / replacement as necessary.

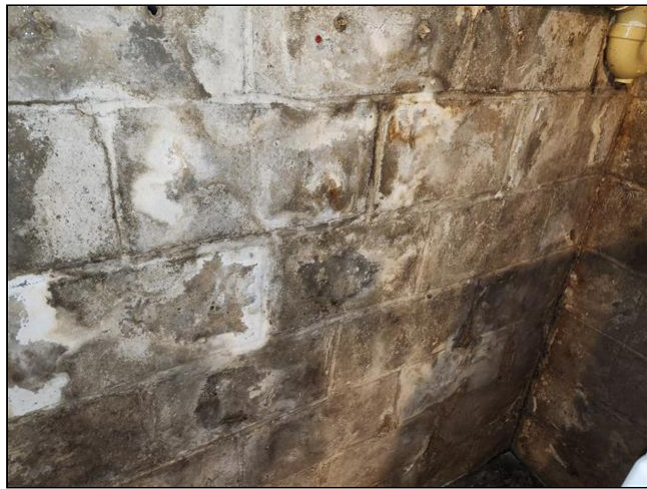
3.1 Item 5 (Picture)

Efflorescence is present on the foundation wall(s). This is a mineral deposit left behind from persistent exterior water infiltration. This is most often resolved by improving exterior drainage away from foundation. Recommend repairs to eliminate moisture.

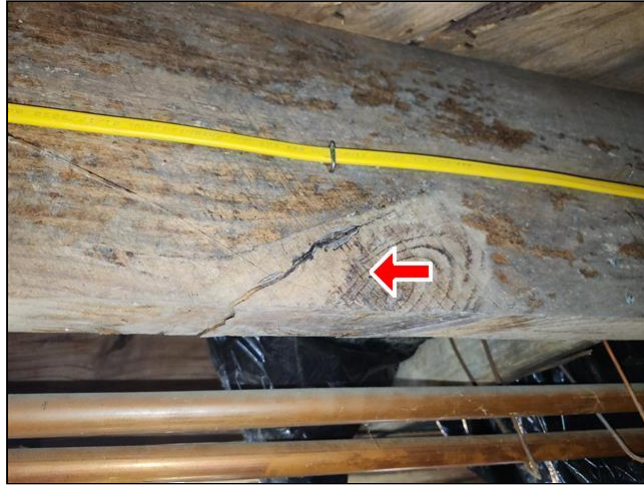
3.3 Item 3 (Picture)

Cracked/damaged joists observed in the basement at left side of the home. Recommend repairs as needed.

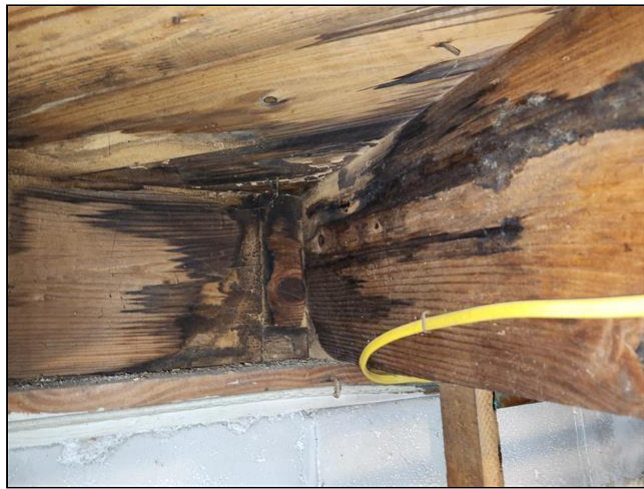
3.3 Item 4 (Picture)

Moisture staining present at: multiple locations in the basement, tested dry at time of inspection.

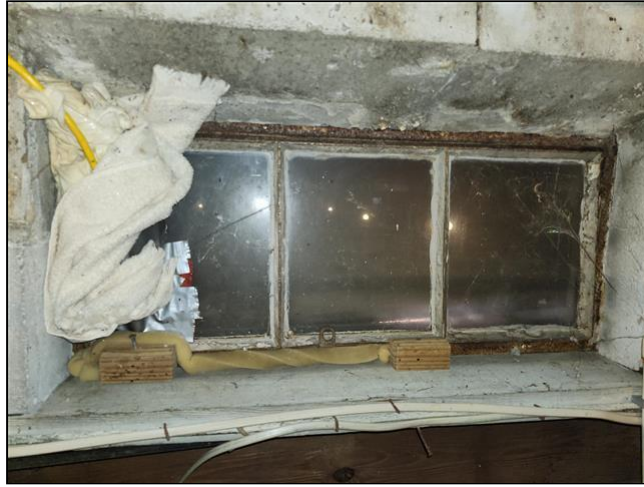
3.4 Item 1 (Picture)

Window will not open at basement. Rust present at all windows as well. Recommend repair to correct this condition.

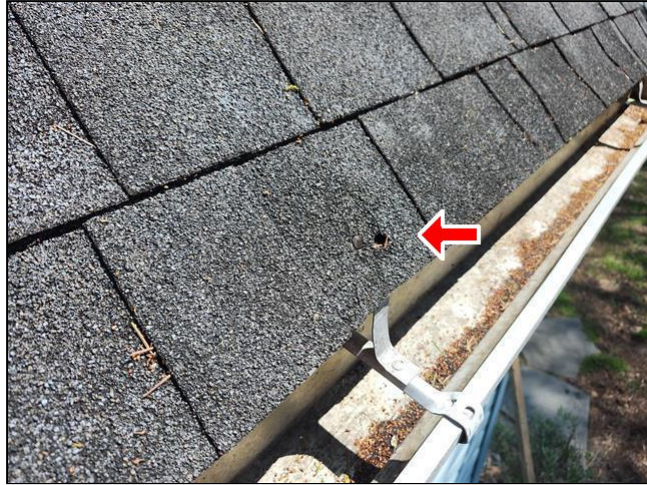
4.0 Item 1 (Picture)

Nails have penetrated through the shingles at rear of the home. Recommend repairs to correct this condition to prevent leakage.

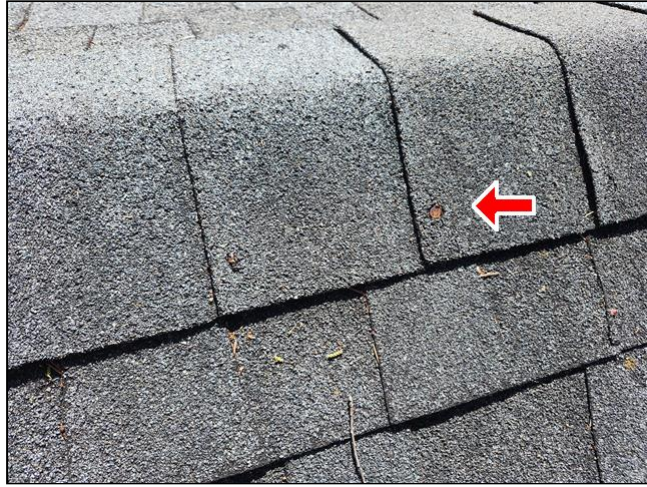
4.0 Item 4 (Picture)

Nails are not sealed at cap shingles at various locations. Nail heads should be sealed to prevent water penetration as a part of routine maintenance.

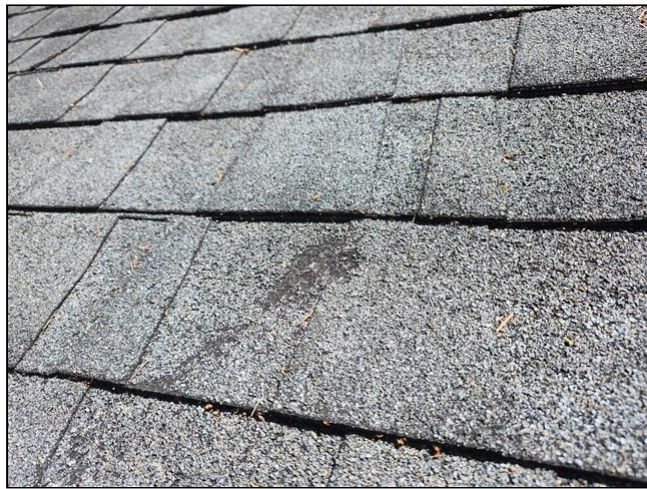
4.0 Item 5 (Picture)

Materials show signs of age and general wear with granular loss, staining, and cupping.

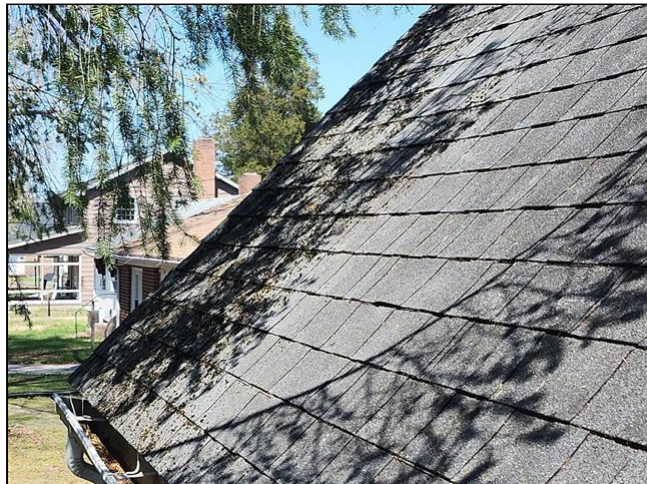
4.0 Item 6 (Picture)

Moss observed on roof covering at various locations. Suggest having moss removed to prevent accelerated roof deterioration. No evidence of leakage at this time.

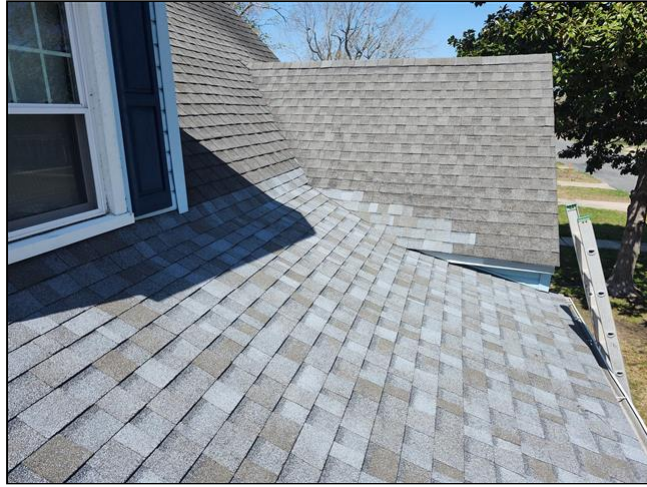
4.0 Item 7 (Picture)

Patching observed at front and second story. Inspector is unable to determine the effectiveness of these repairs.

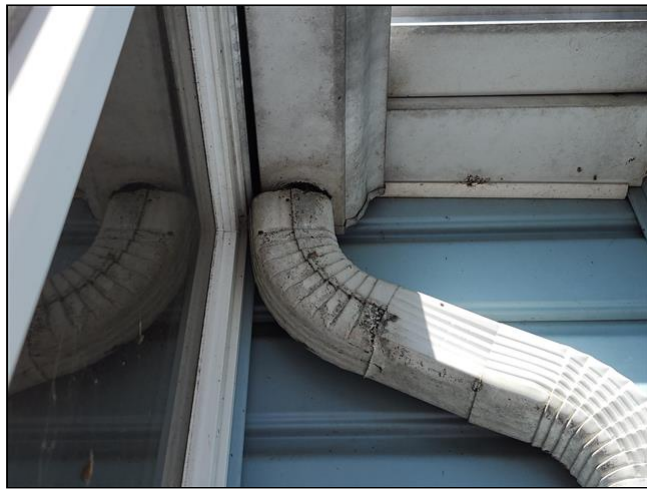
4.2 Item 1 (Picture)

Poor connection from gutter to downspouts on left side (middle of the home). Recommend securing connection for proper flow of water away from the home.

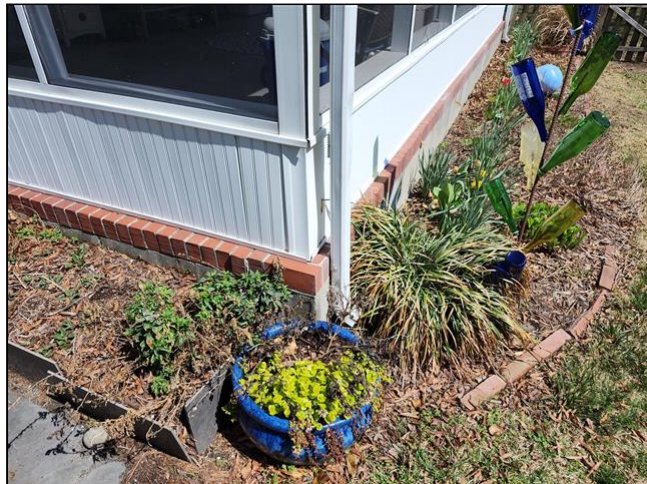
4.2 Item 2 (Picture)

The downspout is loose and needs securing to the wall at the left corner (facing rear).

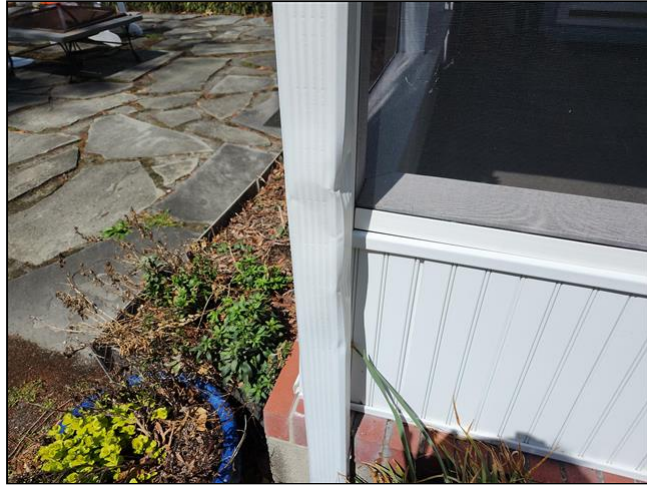
4.2 Item 3 (Picture)

Minor damage observed at multiple locations.

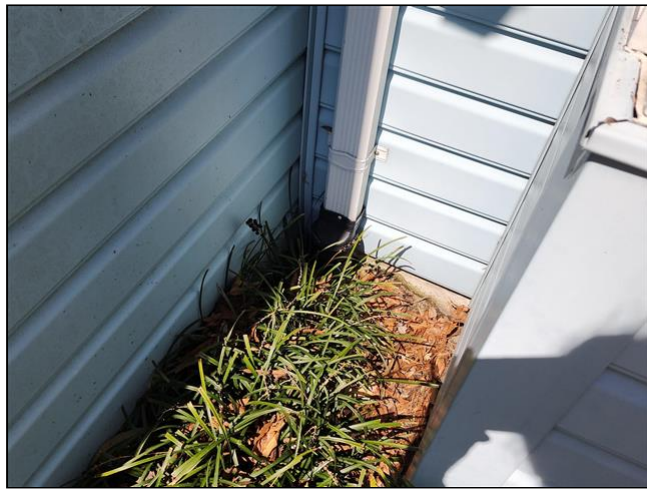
4.2 Item 4 (Picture)

Downspouts exit into an underground drainage system. Underground drainage systems are not within the scope of this inspection and a functional water flow test is not performed. Drains to underground drain piping which was not tested.

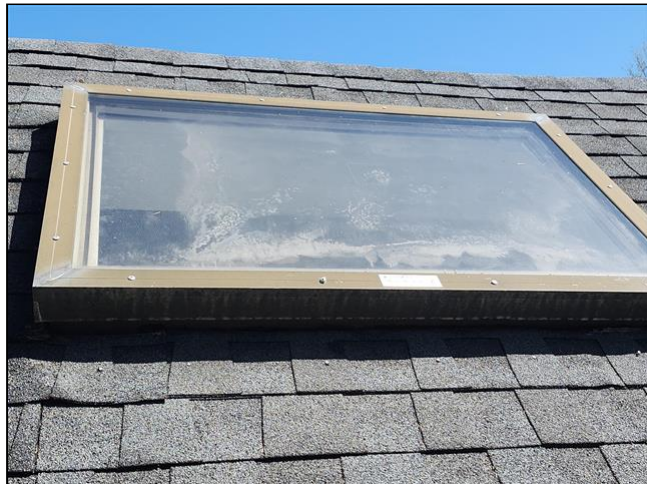
4.3 Item 1 (Picture)

Fog and condensation was noted in this double glazed insulated window panes at rear of home. This indicates a broken seal which will reduce visibility and the insulating capability of this window. To restore visibility and regain the insulating capability, replacement of this window pane is required.

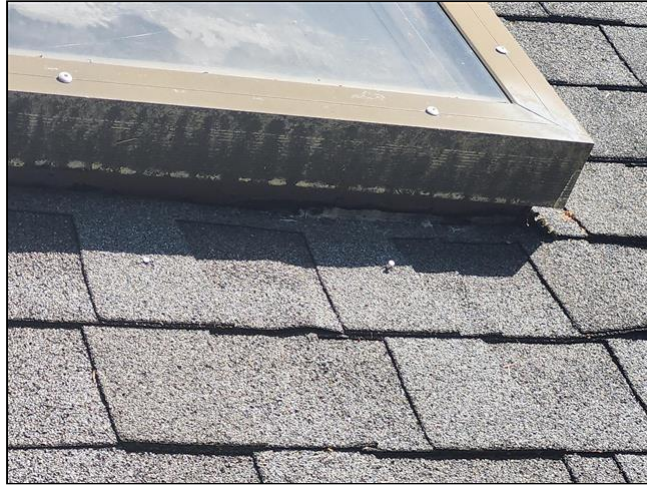
4.3 Item 2 (Picture)

Patching observed indicating prior leakage. Unable to determine if leak has been remedied. Suggest consulting roofer for further evaluation and repair/replacement as necessary.

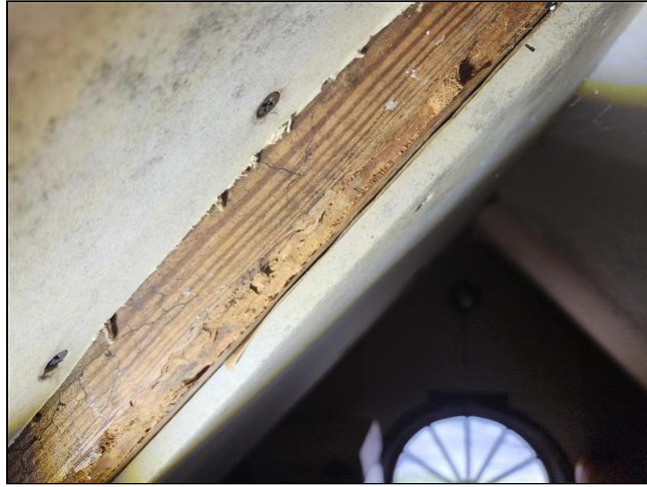
6.1 Item 4 (Picture)

6.1 (3) Framing: Note: Mud tubes present at walk-in attic section. See wood destroying insect inspection for more information.

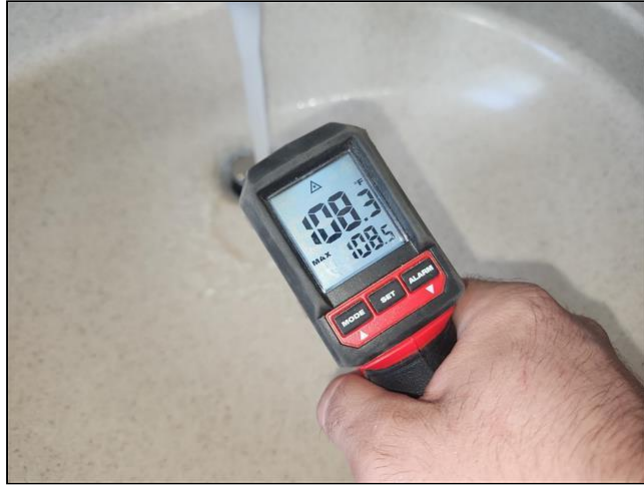
9.1 Item 1 (Picture)

The water temperature at time of inspection was 108 degrees, which is below the normal operating range of 120 to 125 degrees. This may be a setting adjustment or may indicate an issue with the water heaters performance. Recommend further review and repair / replacement as necessary.

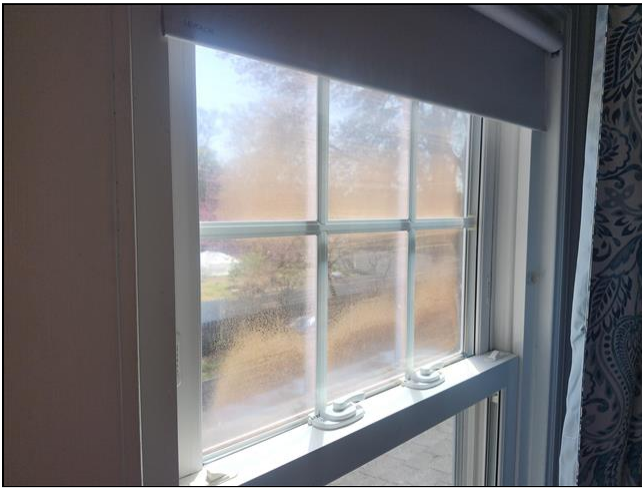
12.4 Item 1 (Picture)

Fog and condensation was noted in the double glazed insulated window panes in the 2nd floor bedroom (left side) and loft. This indicates a broken seal which not only reduces visibility but also reduces the insulating capability of this window. To restore visibility and regain the insulating capability, replacement of this window pane is required.

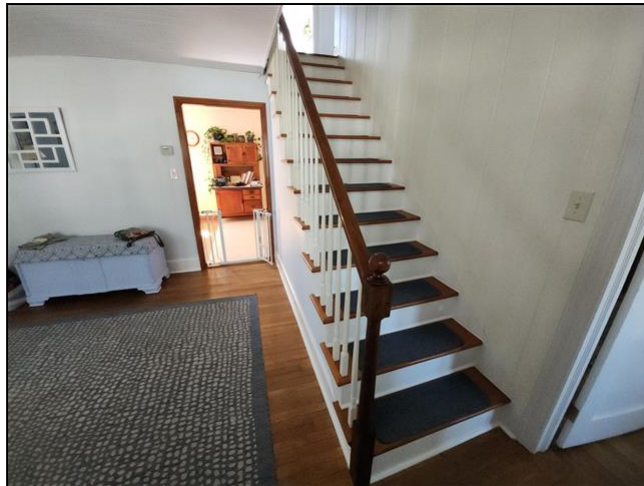
12.5 Item 3 (Picture)

Guardrail/handrail is loose at main steps.
Recommend correcting to ensure safety.

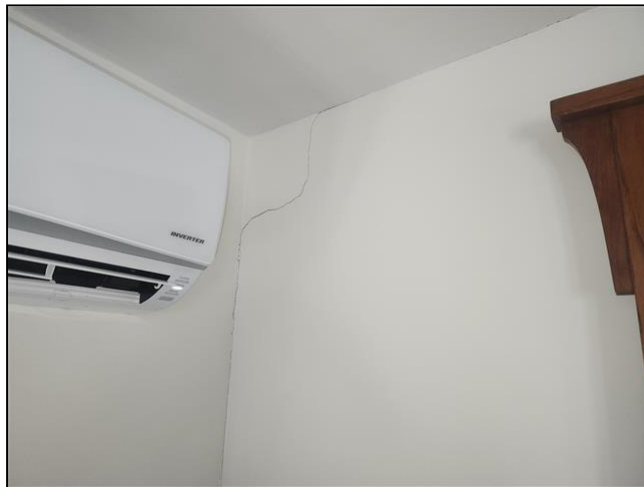
12.7 Item 1 (Picture)

Sloping/uneven floors, door frames not square, wall/ceiling cracks are indicative of settlement which is typical of an older home. Inspector can not determine if condition has stabilized. Recommend consulting seller for further details and consulting a structural specialist if concerned.

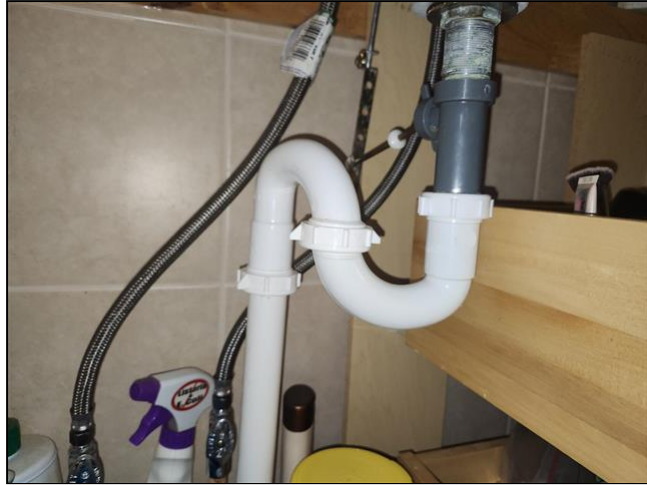
13.1 Item 1 (Picture)

S trap present at the 2nd floor bathroom. While common practice at time of construction, they tend to siphon dry easily and are discouraged from use. Client may want to consider improving trap configuration.

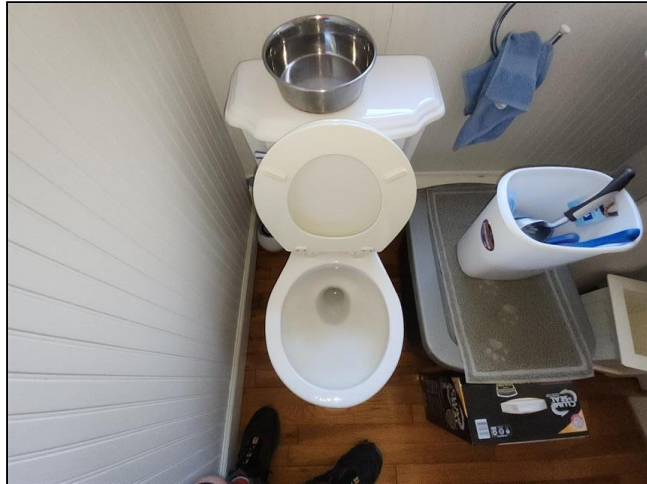
13.2 Item 1 (Picture)

The toilet bowl is moderately to significantly loose at floor anchor bolts in the front right bathroom of the home. The inspector is unable to determine if this is the result of a broken flange or if simply tightening will resolve. The wax ring inside the unit must have a snug, secure fit in order to keep from leaking. Properly re-sealing and re-securing this unit is suggested to prevent water leakage and damage to the sub-floor area. This type of damage is not always visible or accessible to the inspector at time of inspection. Recommend repair / replacement as necessary.

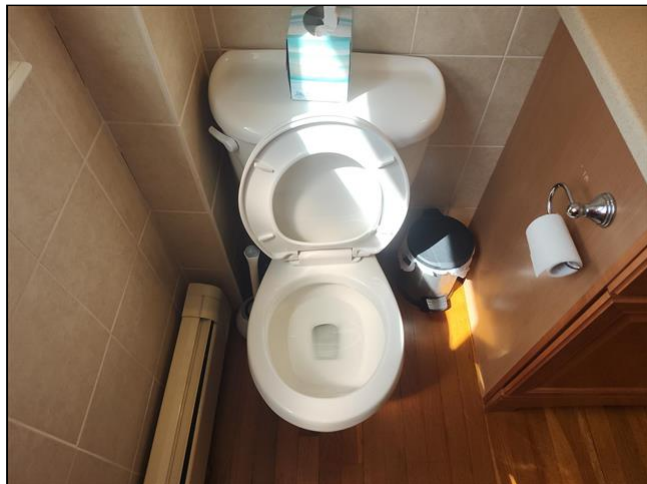
13.2 Item 2 (Picture)

The toilet bowl is slightly loose at floor anchor bolts in the 2nd floor hall bathroom. The wax ring inside the unit must have a snug, secure fit in order to keep from leaking. This type of damage is not always visible or accessible to the inspector at time of inspection. Recommend tightening to prevent leakage. Future repair may be needed if toilet continues to come loose.

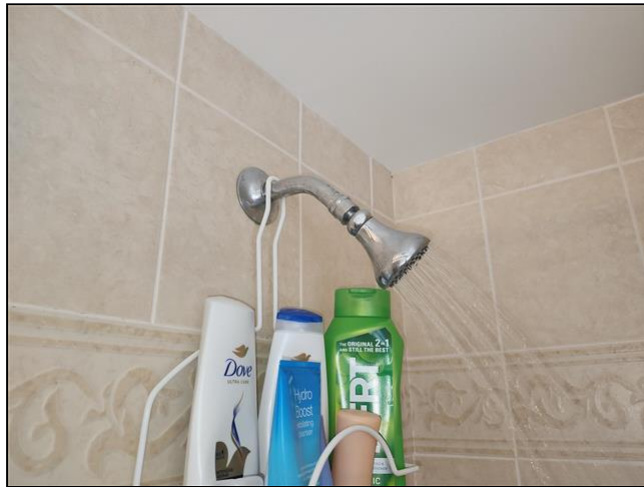
13.3 Item 1 (Picture)

Shower mast in both bathrooms are loose in the wall; recommend correcting.
