Home Inspection Report

Prepared for: James Riddle
Inspection #: 202504-60632
Inspection Address: 3 Orchard Rd
Seaford DE 19973

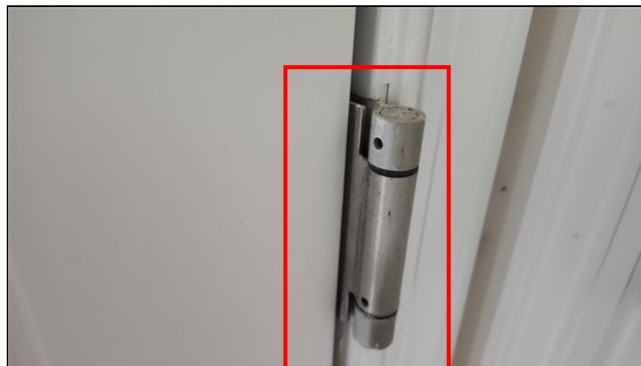
The self-closing device or door hardware needs adjustment or repair to properly close completely and maintain the intended fire safety of this door.

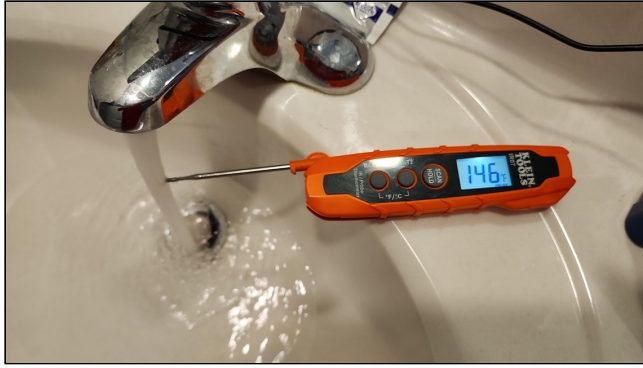
10.1 Item 1 (Picture)

The water temperature at time of inspection was 146 degrees, which is above the normal operating range of 120 to 125 degrees. This is a safety concern. Recommend lowering temperature to prevent scalding.

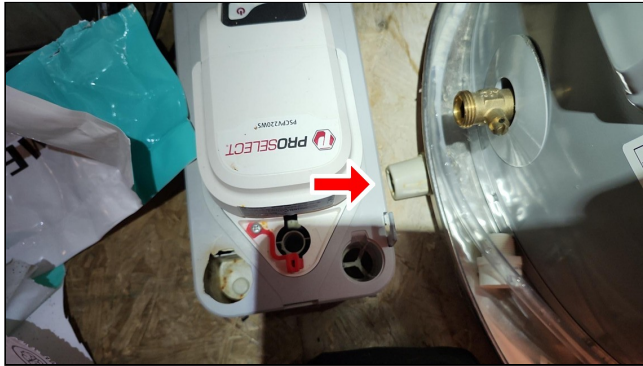
10.5 Item 1 (Picture)

Drain line missing / not run to exterior / french drain. Recommend correcting for proper operation of emergency feature.

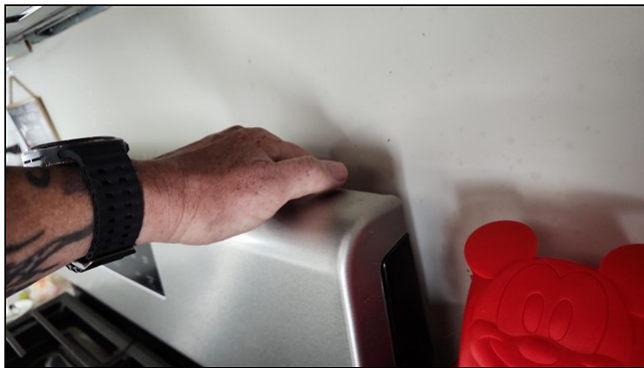
11.3 Item 3 (Picture)

A stove anti tip over device has not been installed on this unit. If a child steps on the open door or if a heavy pot is placed on the door, the door acts like a lever forcing the front of the stove down and then back up. Not only will the stove tip and possibly land on your feet, but anything on the range top, such as a pot of boiling water which could cause serious injury. An anti tip bracket can be attached to the bottom of the wall behind the stove by a licensed general contractor. The stove will still slide in and out but will not tip over. Recommend installing to ensure safety. (Attached photo is an example, not the actual unit).

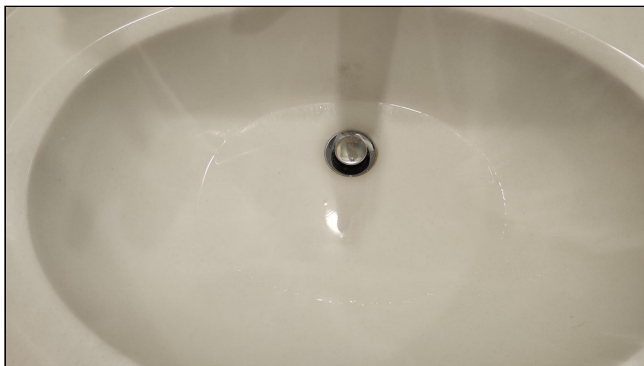
12.1 Item 1 (Picture)

The sink does not drain properly (clogged / slow draining) at the master bathroom. Recommend repairs as needed.

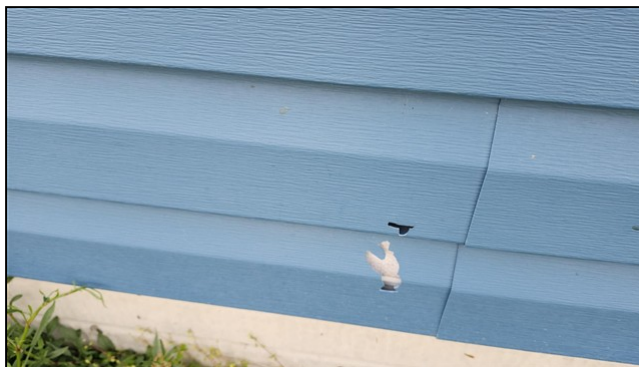
1.6 Item 1 (Picture)

Damaged and/or missing siding observed at: various locations .
Recommend repair / replacement as necessary.

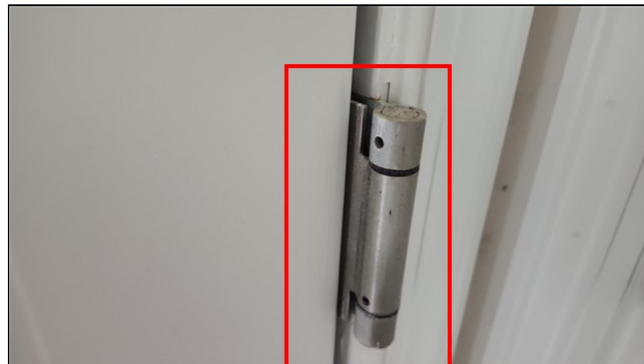
The self-closing device or door hardware needs adjustment or repair to properly close completely and maintain the intended fire safety of this door.

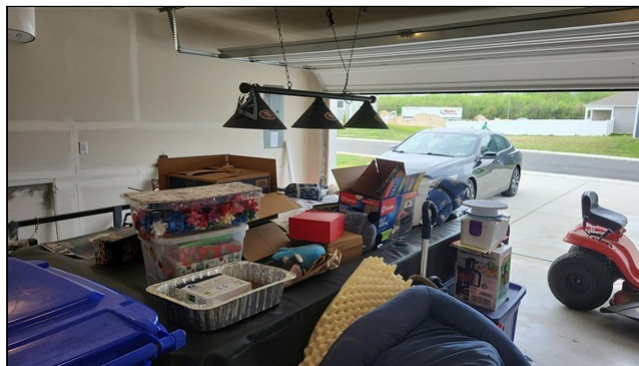
2.7 Item 1 (Picture)

Limited review of the garage due to stored items, shelving, cluttered condition.

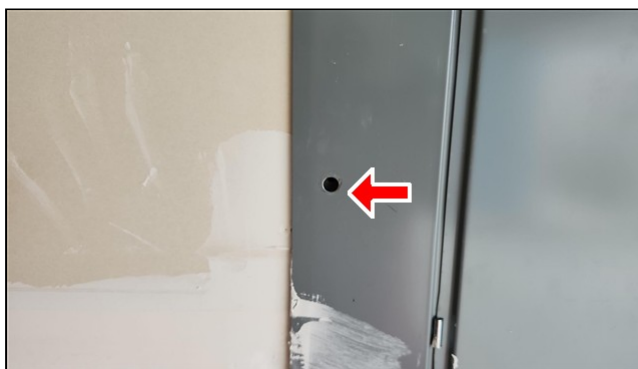
6.2 Item 1 (Picture)

Missing panel screws were noted in the main panel. Recommend that a qualified electrician secure the panel cover with the appropriate type screws, to help assure safety and serviceability.

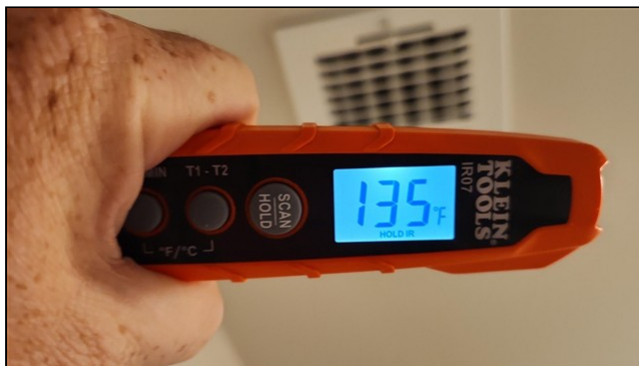
7.1.A Item 1 (Picture)

The furnace was tested using normal operating controls and supplied a temperature of 135 degrees. Due to inaccessibility of many of the components of this unit, the review is limited. Holes or cracks in the heat exchanger are not within the scope of this inspection as heat exchangers are not visible or accessible to the inspector. Unit was operated by the thermostat. As with all mechanical equipment the unit can fail at anytime without warning. Inspectors cannot determine future failures.

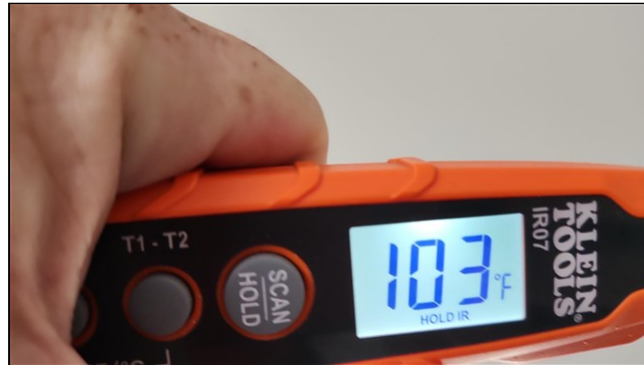
7.1.B Item 1 (Picture)

The furnace was tested using normal operating controls and supplied a temperature of 103 degrees. Due to inaccessibility of many of the components of this unit, the review is limited. Unit was operated by the thermostat. As with all mechanical equipment the unit can fail at anytime without warning. Inspectors cannot determine future failures.

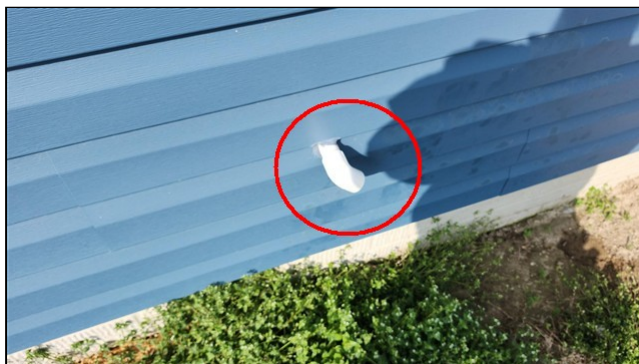
8.1.B Item 1 (Picture)

Air conditioning condensate drain line discharges too close to foundation. Recommend discharging away from foundation to prevent foundation moisture penetration.

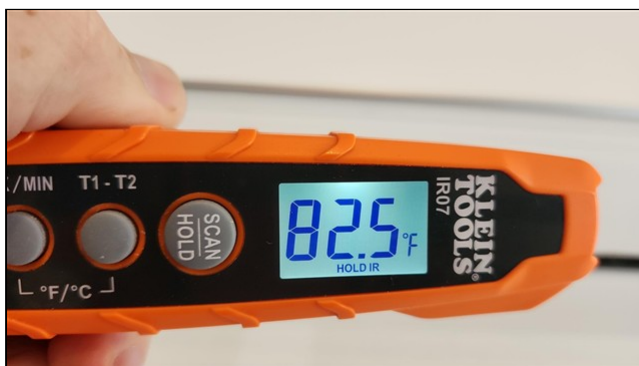
8.2.B Item 1 (Picture)

Additionally, as most manufacturers warn against operating air conditioning units when the outside temperature is below 60 degrees and heat pumps air conditioning units below 65 degrees, the a/c mode of this unit was not tested. Recommend referring to the Sellers Disclosure Statement regarding the operation of this mode or licensed HVAC contractor if concerned.

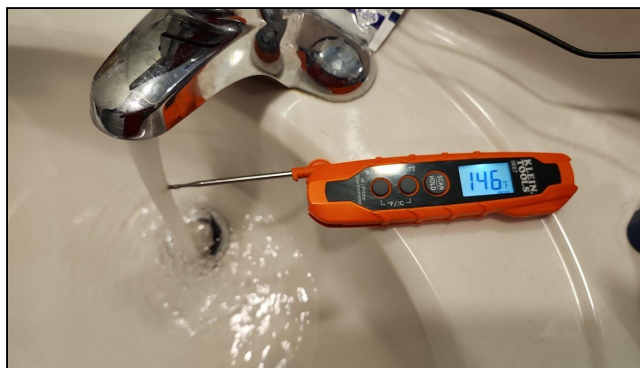
10.1 Item 1 (Picture)

The water temperature at time of inspection was 146 degrees, which is above the normal operating range of 120 to 125 degrees. This is a safety concern. Recommend lowering temperature to prevent scalding.

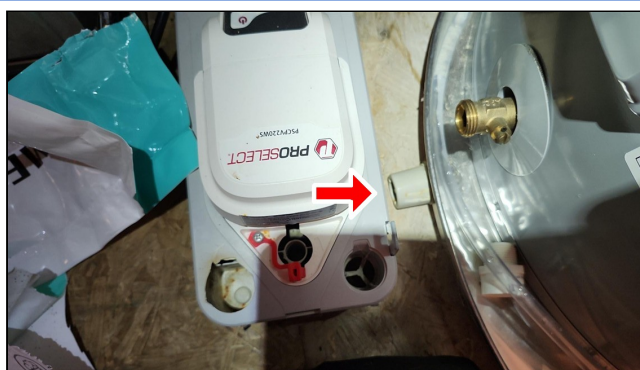
10.5 Item 1 (Picture)

Drain line missing / not run to exterior / french drain. Recommend correcting for proper operation of emergency feature.

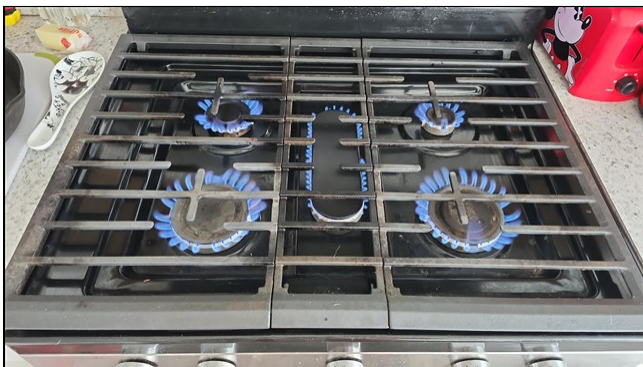
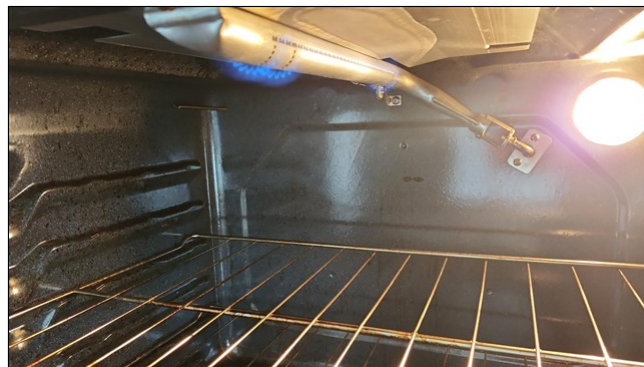
NOTE: The gas stove/range elements were tested at the time of inspection and appeared to function properly. These can fail at anytime without warning. No warranty, guarantee, or certification is given as to future failure.

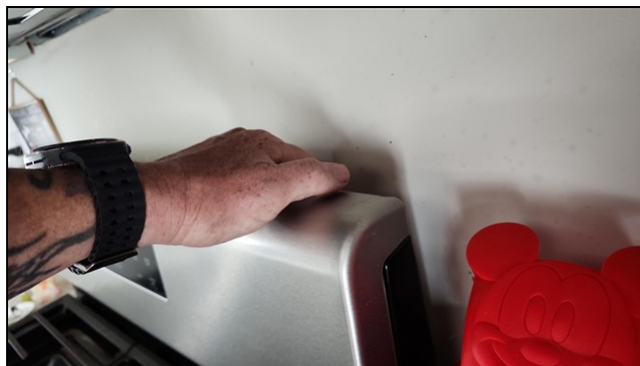
11.3 Item 3 (Picture)

A stove anti tip over device has not been installed on this unit. If a child steps on the open door or if a heavy pot is placed on the door, the door acts like a lever forcing the front of the stove down and then back up. Not only will the stove tip and possibly land on your feet, but anything on the range top, such as a pot of boiling water which could cause serious injury. An anti tip bracket can be attached to the bottom of the wall behind the stove by a licensed general contractor. The stove will still slide in and out but will not tip over. Recommend installing to ensure safety. (Attached photo is an example, not the actual unit).

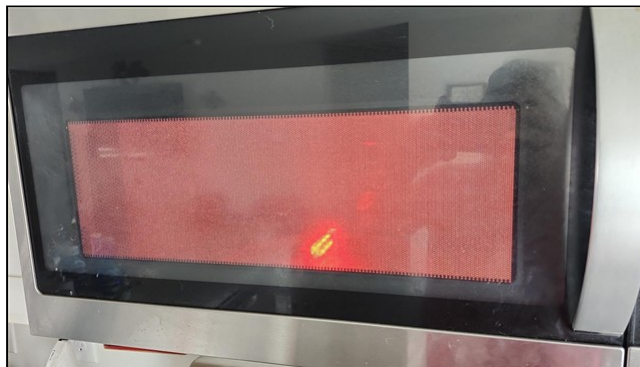
11.5 Item 1 (Picture)

Built-in microwave ovens are tested using normal operating controls. Unit was tested and was serviceable at time of inspection. Leak and/or efficiency testing is beyond the scope of this inspection.

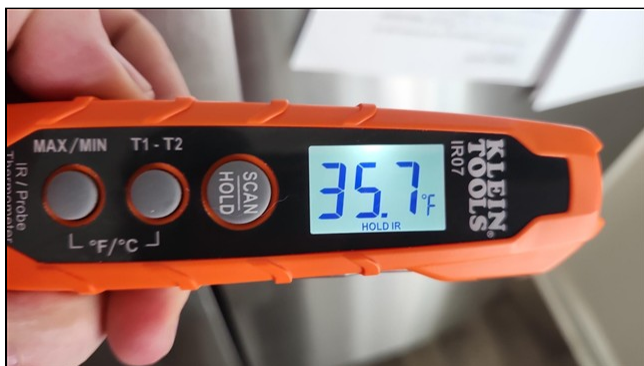
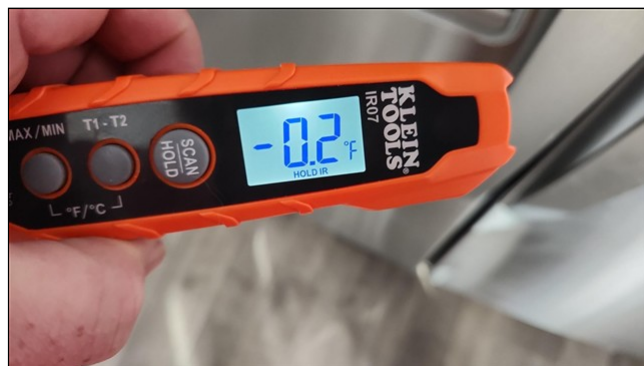
The refrigerator/freezer, freon levels, icemaker operation and other specialty items are beyond the scope of inspection. A temperature reading ONLY was taken for your information only. The refrigerator should be kept at or below 40 degrees fahrenheit and the freezer at or below 0 degrees. The refrigerator supplied temperature at 35 degrees and the freezer at 0 degrees.

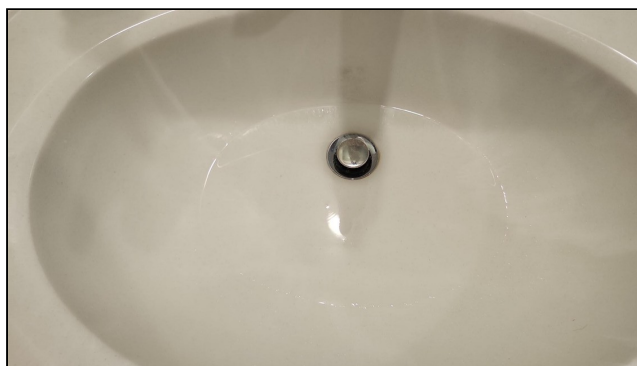
12.1 Item 1 (Picture)

The sink does not drain properly (clogged / slow draining) at the master bathroom. Recommend repairs as needed.

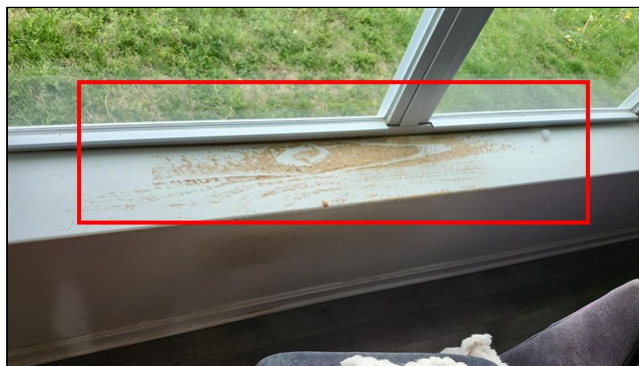
14.4 Item 1 (Picture)

Window wood deterioration observed in the living room window sill. Suggest repairs/replacement as needed.

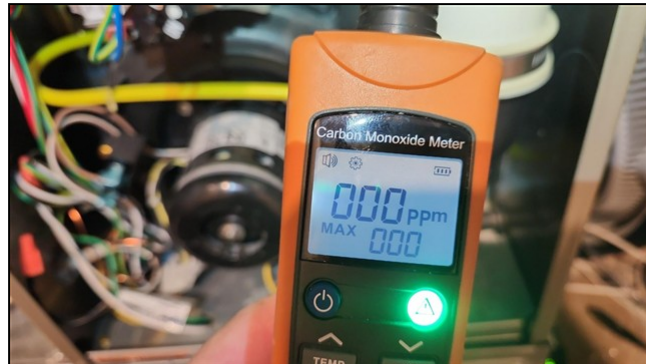
15.1 Item 1 (Picture)

Fuel burning appliances were tested for Carbon Monoxide with results of 0 which is an acceptable level of carbon monoxide in a living space.
