Home Inspection Report

Prepared for: Debbie Fees
Inspection #: 202504-60493
Inspection Address: 514 North Willey Street
Seaford DE 19973

Inspection Company: **Amerispec**
Office: 302-996-0405
Inspector: Clay Ballard Lic # DE H4-0010250

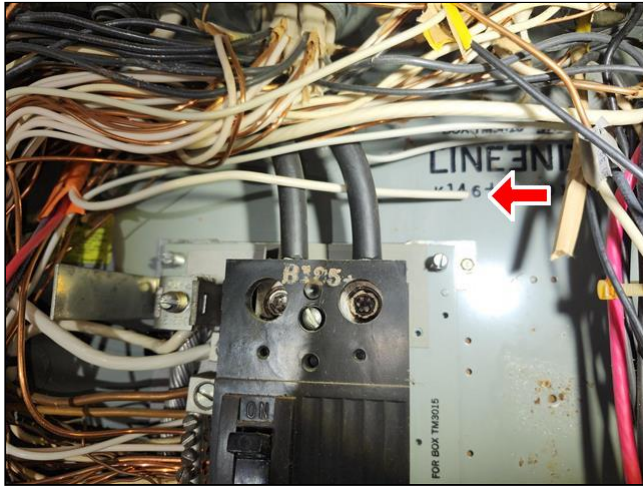
2.3 Item 1 (Picture)

Abandoned, uncapped wiring observed at main panel. Whenever an electric wire is cut it should be capped and encased in a covered junction box to prevent a potential shock / fire hazard in the event the line were to become live.

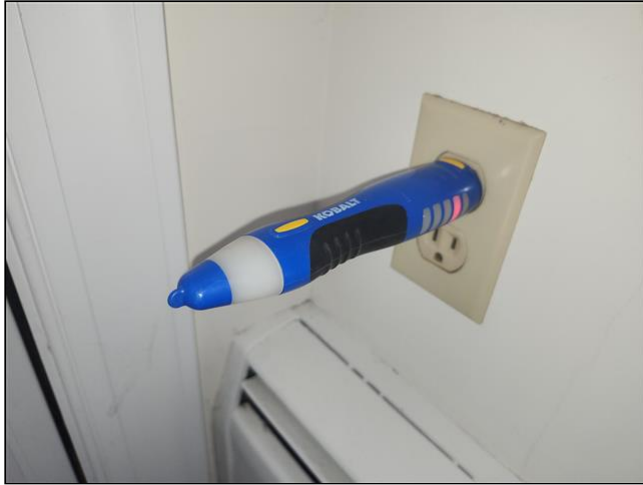
2.7 Item 1 (Picture) Left bedroom 2nd floor

Ungrounded three prong outlets observed at multiple locations. It is recommended that these type receptacles be grounded, replaced with two prong receptacles, or protected on a GFCI receptacle as applicable. Recommend repairs / replacements as needed to ensure safety.

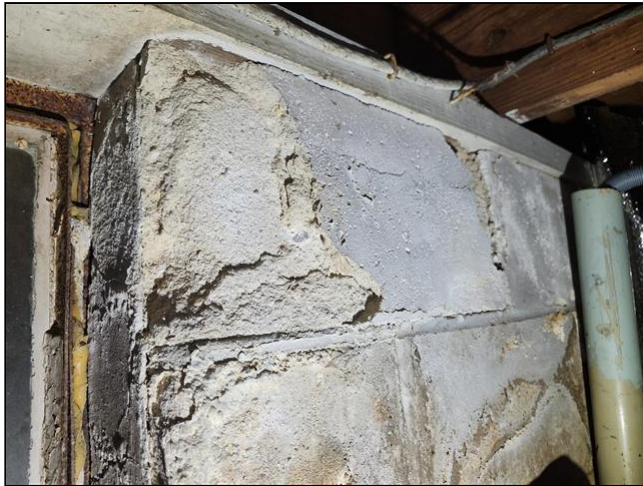
3.1 Item 4 (Picture)

Spalling block observed at: foundation wall. Recommend further review for repair / replacement as necessary.

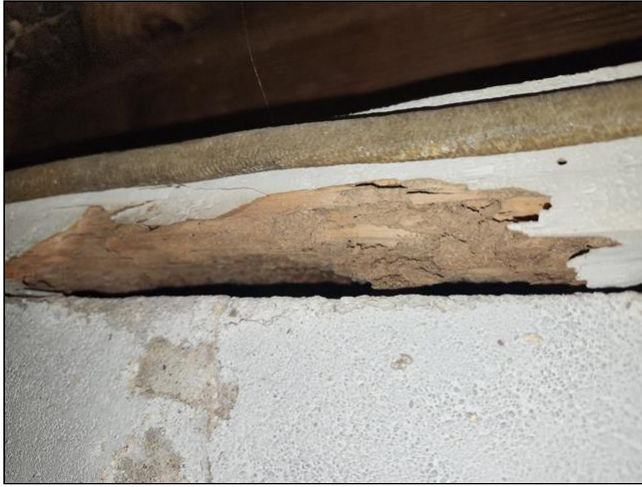
3.3 Item 1 (Picture)

Evidence of pest, wood destroying insect damage observed on the beam and sill plate in the basement. See Wood Destroying Insect Inspection Report.

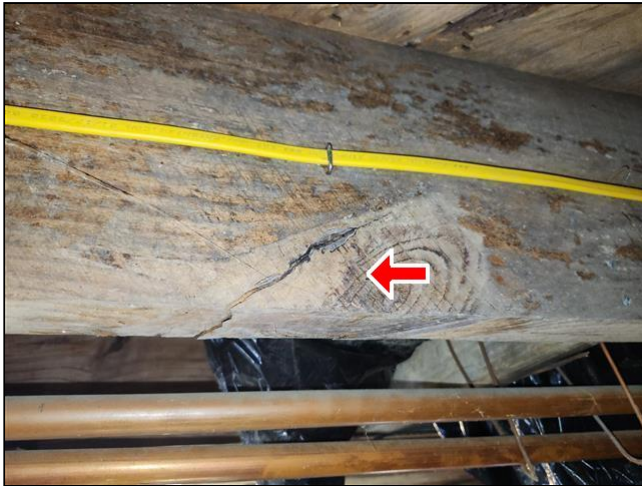
3.3 Item 3 (Picture)

Cracked/damaged joists observed in the basement at left side of the home. Recommend repairs as needed.

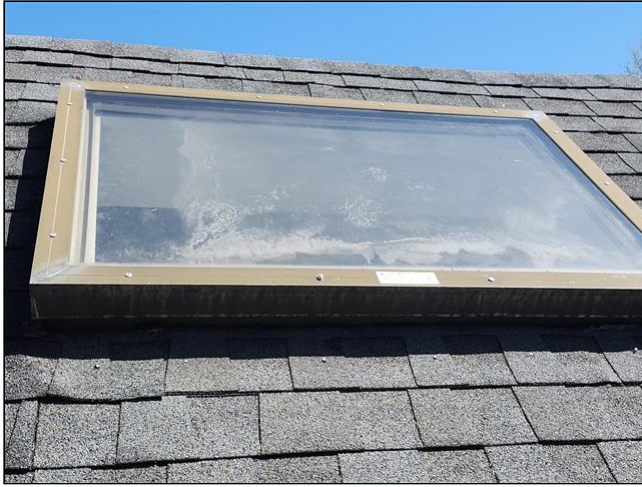
4.3 Item 1 (Picture)

Fog and condensation was noted in this double glazed insulated window panes at rear of home. This indicates a broken seal which will reduce visibility and the insulating capability of this window. To restore visibility and regain the insulating capability, replacement of this window pane is required.

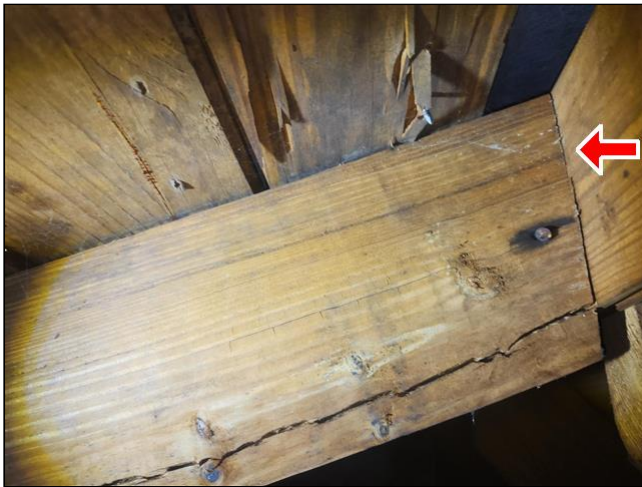
6.1 Item 1 (Picture)

Cracked / damaged rafter(s) observed. Recommend review by a structural engineer or other qualified professional for repair / replacement as necessary.

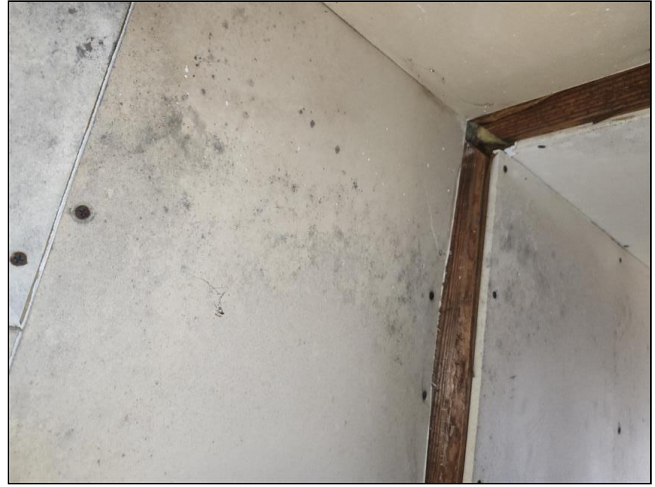
6.2 Item 2 (Picture)

Possible microbiological growth observed (walk-in section). Because certain types of microbiological spores may result in adverse health effects, it is strongly recommended that a microbiological inspection be performed by a qualified licensed professional and that corrective measures be taken to eliminate both microbiological growth and moisture related conditions.

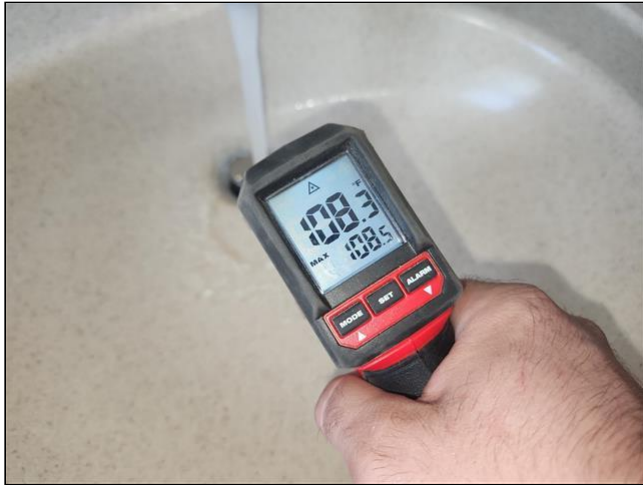
9.1 Item 1 (Picture)

The water temperature at time of inspection was 108 degrees, which is below the normal operating range of 120 to 125 degrees. This may be a setting adjustment or may indicate an issue with the water heaters performance. Recommend further review and repair / replacement as necessary.

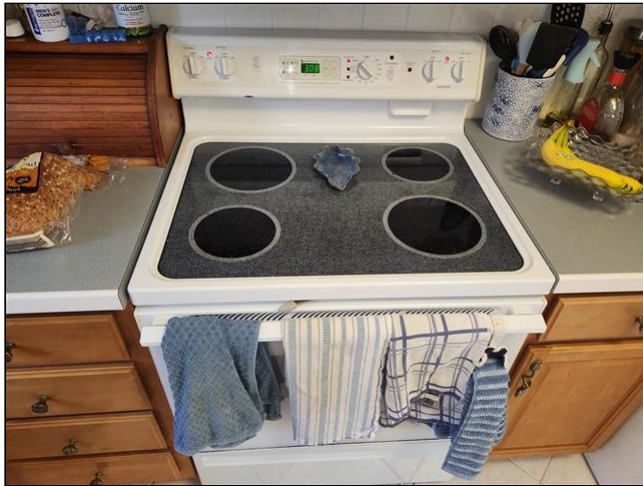
11.2 Item 1 (Picture)

A stove anti tip over device has not been installed on this unit. If a child steps on the open door or if a heavy pot is placed on the door, the door acts like a lever forcing the front of the stove down and then back up. Not only will the stove tip and possibly land on your feet, but anything on the range top, such as a pot of boiling water which could cause serious injury. An anti tip bracket can be attached to the bottom of the wall behind the stove by a licensed general contractor. The stove will still slide in and out but will not tip over. Recommend installing to ensure safety. (Attached photo is an example, not the actual unit).

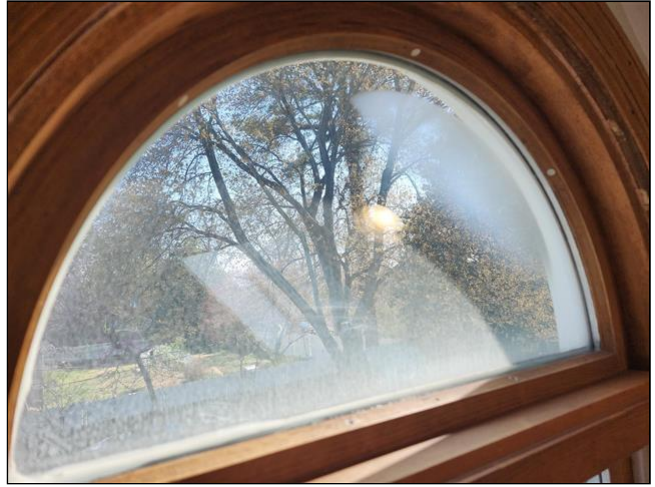
12.4 Item 2 (Picture)

Fog and condensation was noted in the double glazed insulated window panes in the 2nd floor bedroom (left side) and loft. This indicates a broken seal which not only reduces visibility but also reduces the insulating capability of this window. To restore visibility and regain the insulating capability, replacement of this window pane is required.

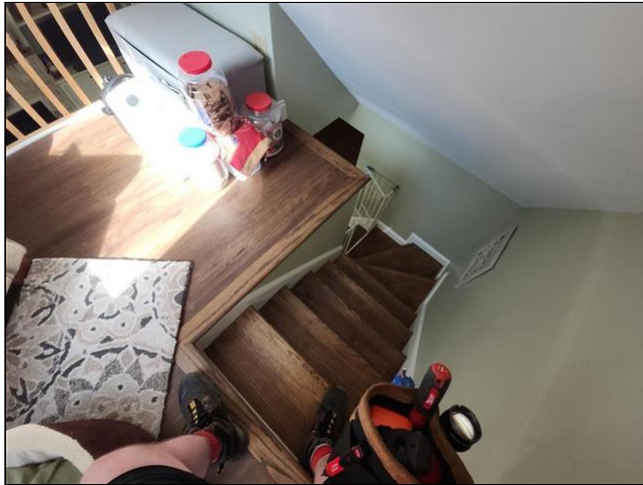
12.5 Item 1 (Picture)

No railings noted at both basement and loft steps, recommend installing guardrails handrails for safety.

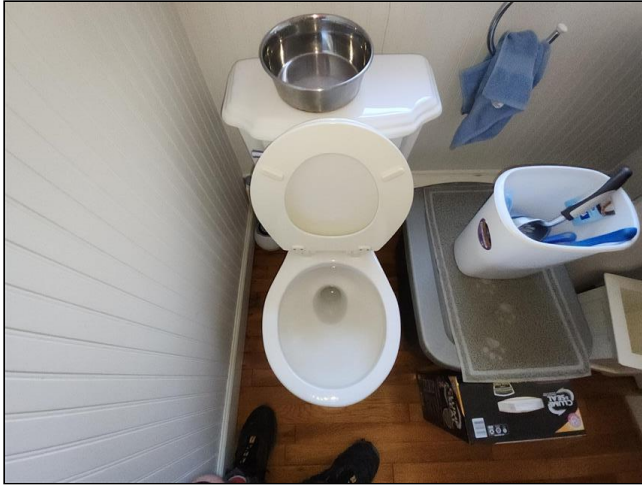
13.2 Item 1 (Picture)

The toilet bowl is moderately to significantly loose at floor anchor bolts in the front right bathroom of the home. The inspector is unable to determine if this is the result of a broken flange or if simply tightening will resolve. The wax ring inside the unit must have a snug, secure fit in order to keep from leaking. Properly re-sealing and re-securing this unit is suggested to prevent water leakage and damage to the sub-floor area. This type of damage is not always visible or accessible to the inspector at time of inspection. Recommend repair / replacement as necessary.

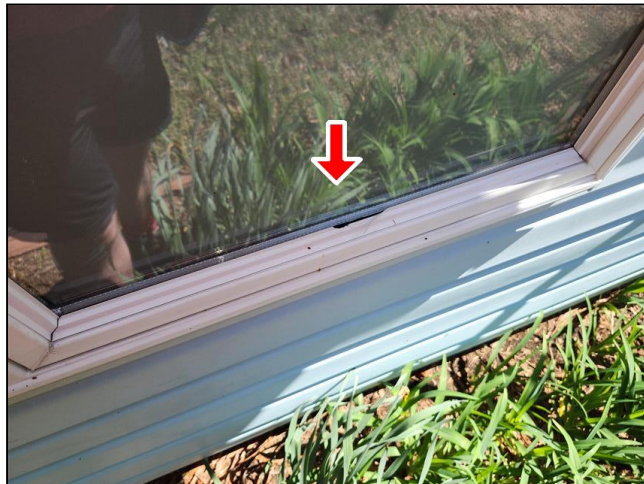
1.8 Item 1 (Picture)

Damaged/deteriorated glazing observed at multiple locations; suggest re-glazing as necessary.

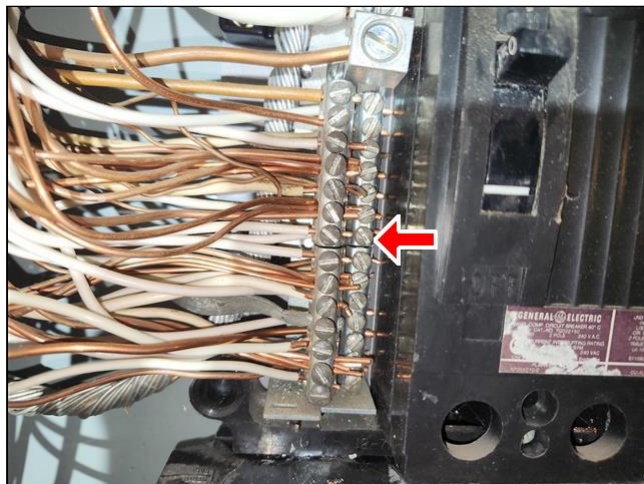
2.2 Item 3 (Picture)

Doubled up neutrals were noted in the main panel which was common practice before 2002. It is considered improper as it can create a poor connection. Each neutral conductor shall terminate within the panel board in an individual terminal that is not also used for another conductor. A licensed electrician is recommended to review this panel and make all corrections necessary to ensure safe and proper operation of the system.

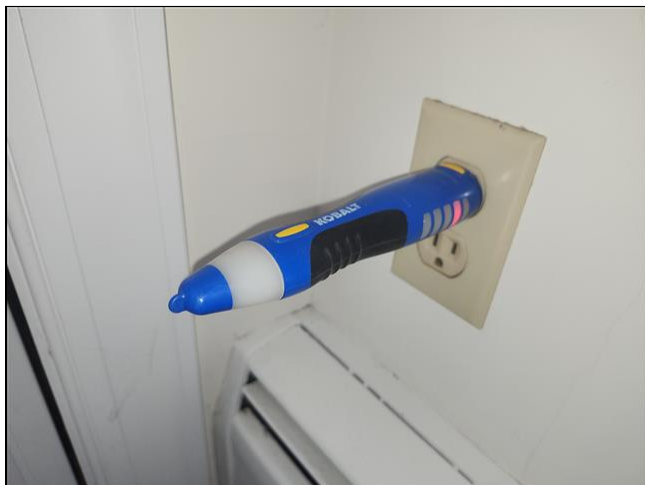
2.7 Item 1 (Picture) Left bedroom 2nd floor

Ungrounded three prong outlets observed at multiple locations. It is recommended that these type receptacles be grounded, replaced with two prong receptacles, or protected on a GFCI receptacle as applicable. Recommend repairs / replacements as needed to ensure safety.

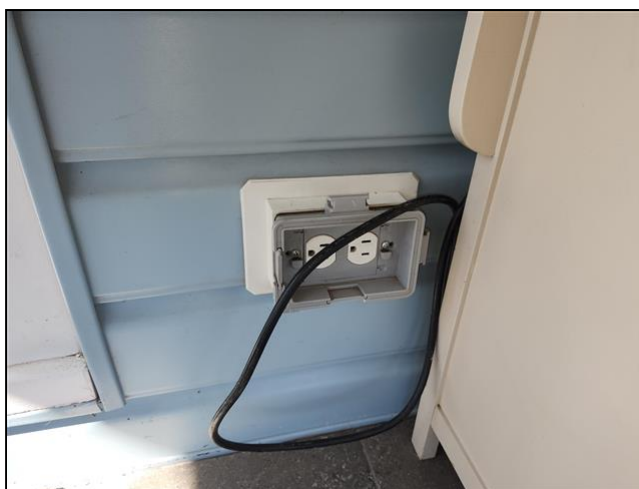
2.7 Item 3 (Picture)

The cover plate at porch is not attached and needs repair or replacement to for safety.

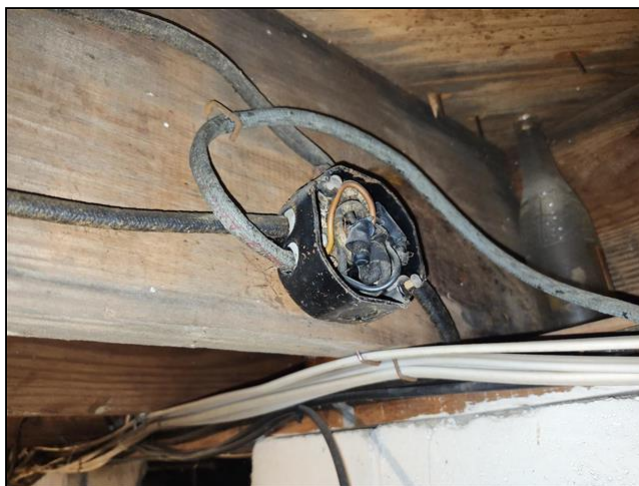
2.8 Item 1 (Picture)

Old electrical junction box/wires are present in the basement. Recommend removal so line does not get electrical charge.

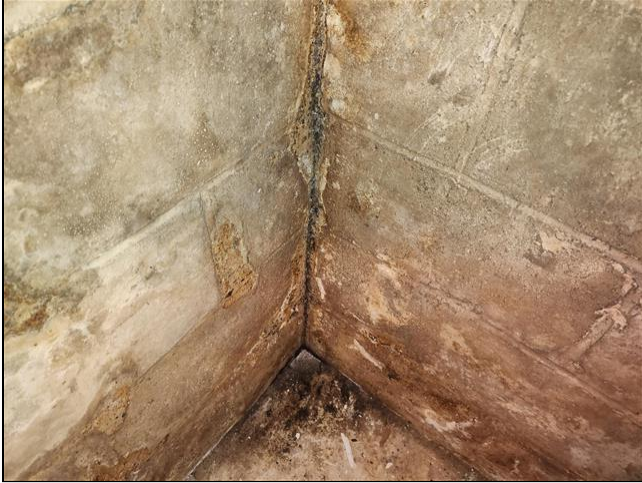
3.1 Item 1 (Picture)

Staining indicates prior water penetration throughout the basement. Staining on the the floor and moisture damaged legs also indicated prior water intrusion. Recommend repairs to eliminate water penetration

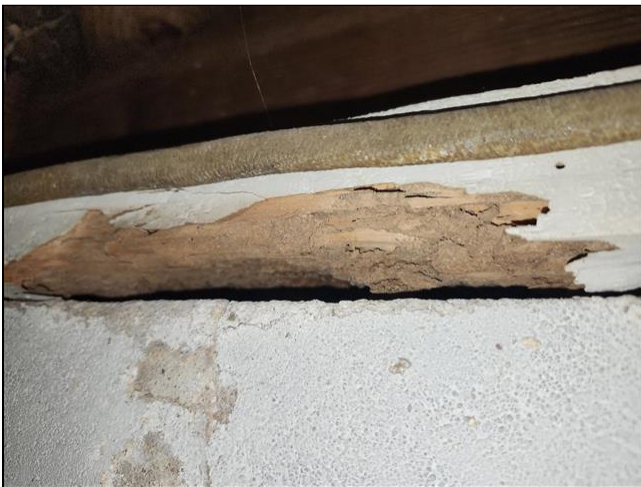
3.3 Item 1 (Picture)

Evidence of pest, wood destroying insect damage observed on the beam and sill plate in the basement. See Wood Destroying Insect Inspection Report.

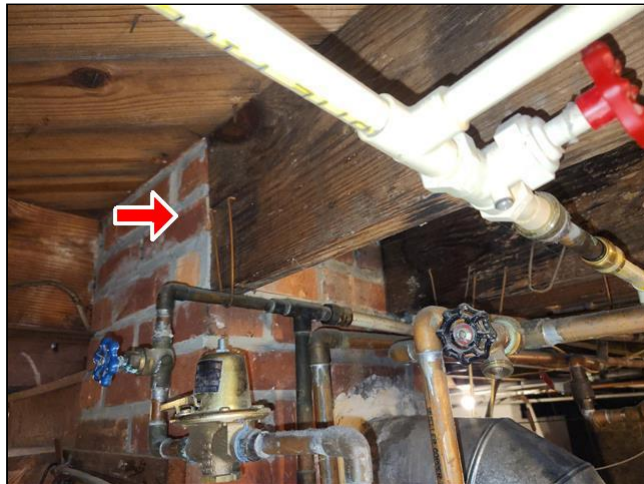
3.3 Item 5 (Picture)

Bearing end appears to be inadequate in basement. Recommend review by specialist and repair as necessary.

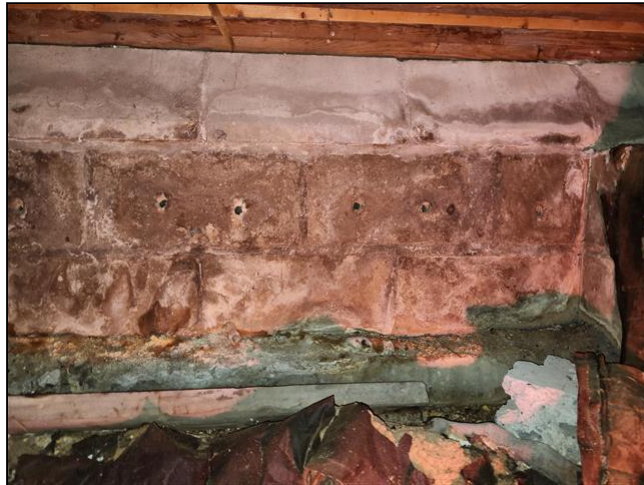
3.6 Item 1 (Picture)

Termite treatment present at the time of inspection.

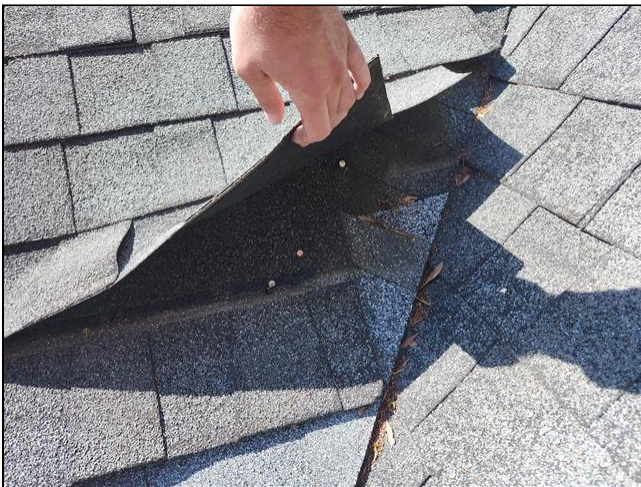
4.0 Item 2 (Picture)

Not all shingles are adhered in place (various locations) which may result in wind damage, recommend correcting to prevent leakage.

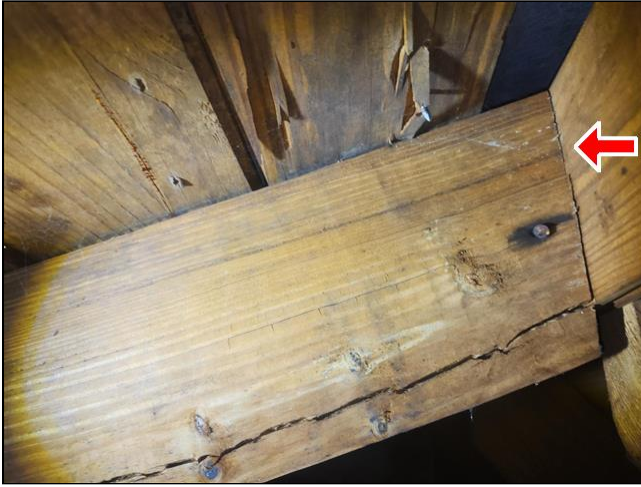
6.1 Item 1 (Picture)

Comments:**6.1 (1) Framing: Major Defect:**

Cracked / damaged rafter(s) observed. Recommend review by a structural engineer or other qualified professional for repair / replacement as necessary.

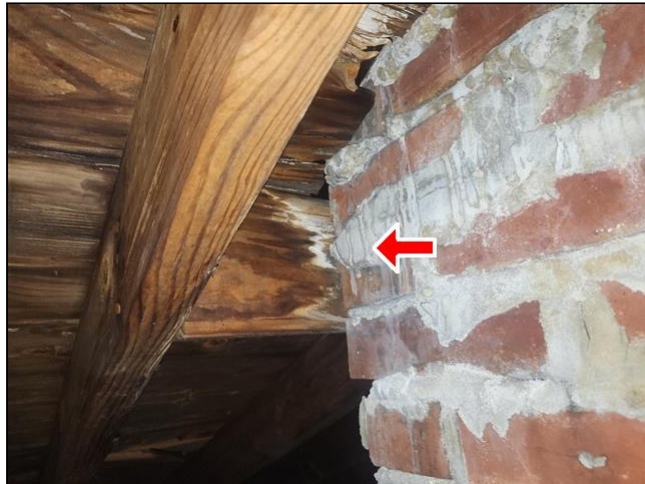
6.1 Item 3 (Picture)

6.1 (2) Framing: Confirm:

Moisture stains present at attic section. Those stains that could be reached tested dry with a moisture meter. Stains at flashings and other various areas are common with older roofs and are often the result of prior leaks. Recommend consulting seller for additional details.

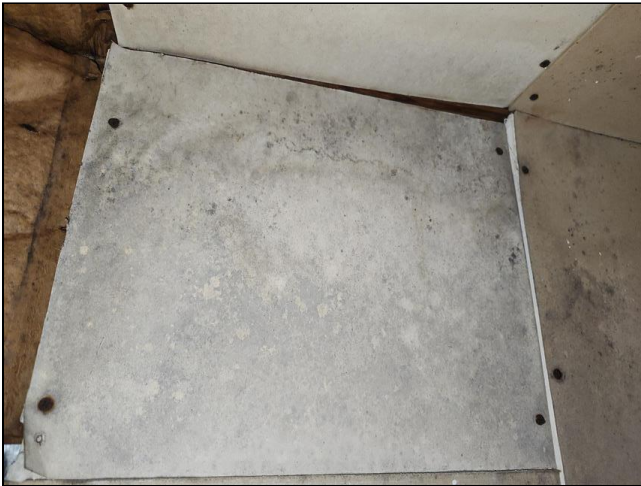
6.2 Item 1 (Picture)

6.2 (1) Sheathing: Major Defect:

Possible microbiological growth observed (walk-in section). Because certain types of microbiological spores may result in adverse health effects, it is strongly recommended that a microbiological inspection be performed by a qualified licensed professional and that corrective measures be taken to eliminate both microbiological growth and moisture related conditions.

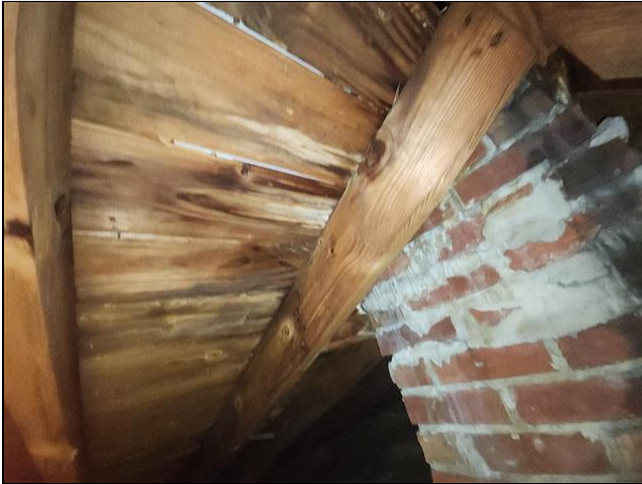
6.2 Item 3 (Picture)

6.2 (2) Sheathing: Confirm:

Moisture stains present at both attic sections. Those stains that could be reached tested dry with a moisture meter. Stains at flashings and other various areas are common with older roofs and are often the result of prior leaks. Recommend consulting seller for additional details.

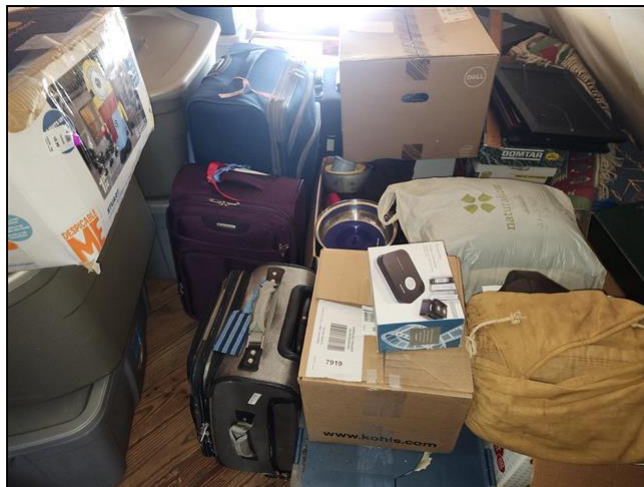
6.5 Item 1 (Picture)

6.5 Attic Comments: Confirm:

Limited review of the attic due to personal property.

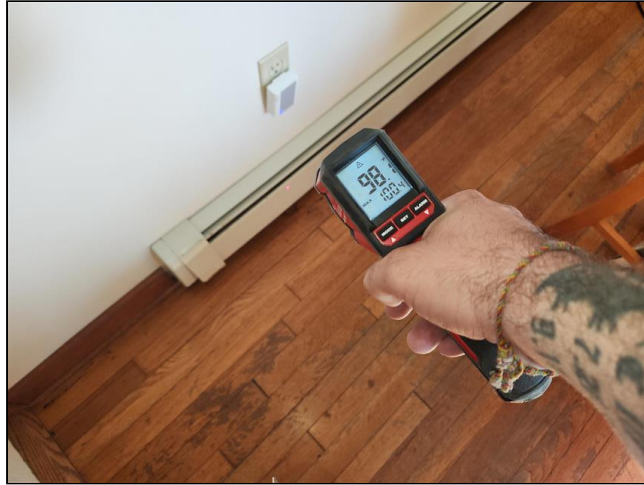
7.1.A Item 1 (Picture)

The boiler was tested using normal operating controls and operated serviceably. Due to inaccessibility of many of the components of this unit, the review is limited. Holes or cracks in the heat exchanger are not within the scope of this inspection as heat exchangers are not visible or accessible to the inspector. Unit was operated by the thermostat. As with all mechanical equipment the unit can fail at anytime without warning. Inspectors cannot determine future failures.

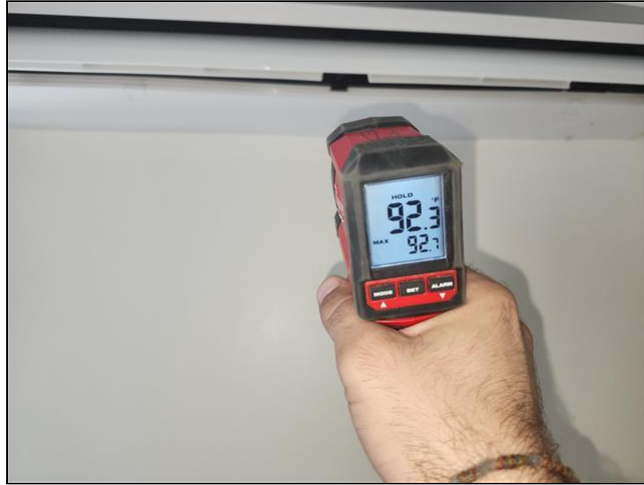
7.1.B Item 1 (Picture)

The furnace was tested using normal operating controls and supplied a temperature of 92 degrees and up from all units. Due to inaccessibility of many of the components of this unit, the review is limited. Unit was operated by the thermostat. As with all mechanical equipment the unit can fail at anytime without warning. Inspectors cannot determine future failures.

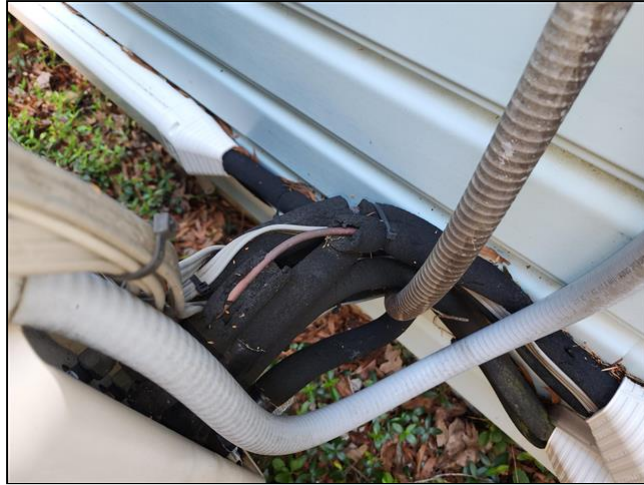
8.0 Item 1 (Picture)

8.0 (1) Cooling Equip Condition:

Maintenance / Monitor:

Damaged / Missing insulation observed on refrigerant line. Recommend correcting to prevent sweating and enhance operating efficiency.

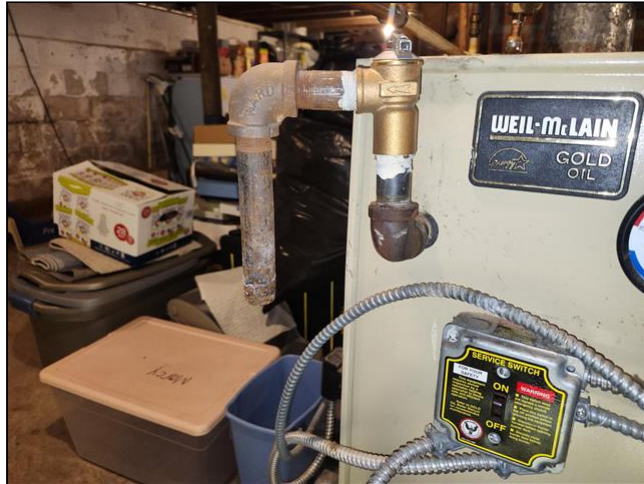
9.5 Item 1 (Picture)

9.5 TPR Valve: **Major Defect:**

The T&P (Test and Pressure) valve on water heater/boiler needs a 3/4 threaded pipe to extend within 6 inches of floor for safety. (PVC is not approved for hot water use). Recommend repair by a qualified plumber.

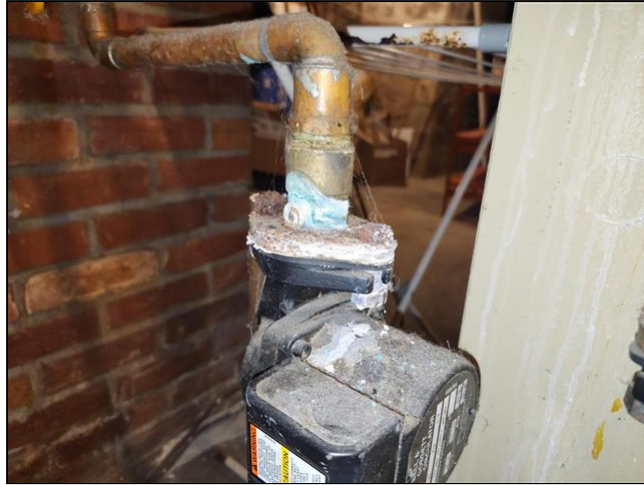
10.1 Item 1 (Picture)

10.1 Supply Pipes: **Maintenance / Monitor:**

Typical rust / corrosion observed at various fittings. No leakage at time of inspection. Future repairs may be needed.

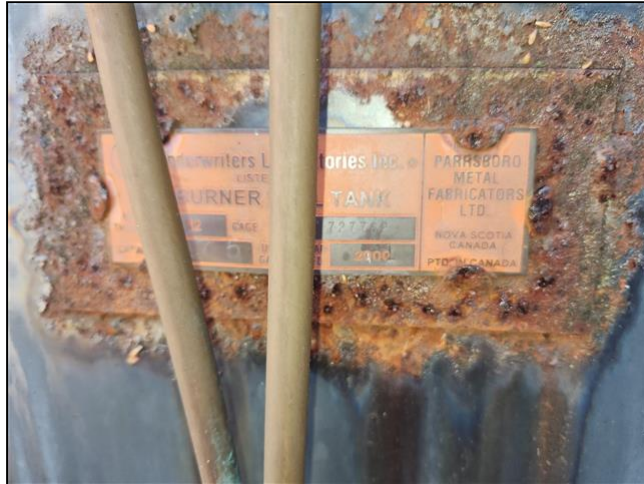
10.3 Item 1 (Picture)

10.3 Fuel Storage Systems:

Maintenance / Monitor:

Rust / Corrosion observed. Recommend painting to extend life.

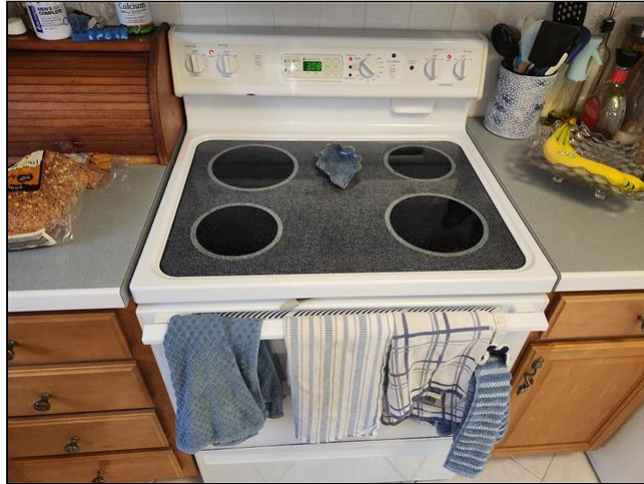
11.2 Item 1 (Picture)

Major Defect:

A stove anti tip over device has not been installed on this unit. If a child steps on the open door or if a heavy pot is placed on the door, the door acts like a lever forcing the front of the stove down and then back up. Not only will the stove tip and possibly land on your feet, but anything on the range top, such as a pot of boiling water which could cause serious injury. An anti tip bracket can be attached to the bottom of the wall behind the stove by a licensed general contractor. The stove will still slide in and out but will not tip over. Recommend installing to ensure safety. (Attached photo is an example, not the actual unit).

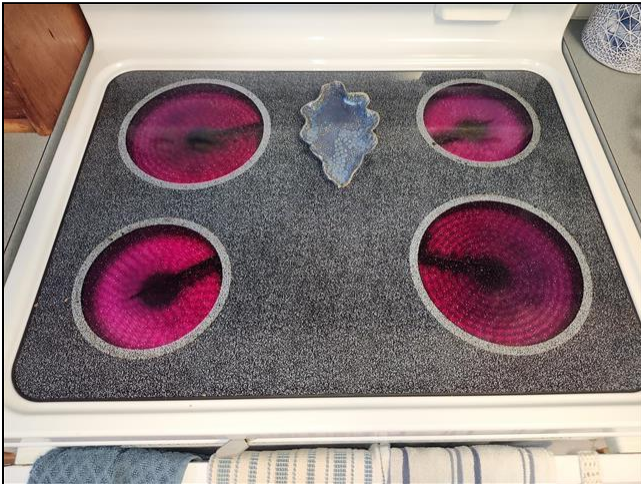
11.2 Item 2 (Picture)

11.2 (2) Ranges/Ovens/Cooktops:

NOTE: The electrical stove/range elements were tested at the time of inspection and appeared to function properly. These can fail at anytime without warning. No warranty, guarantee, or certification is given as to future failure.

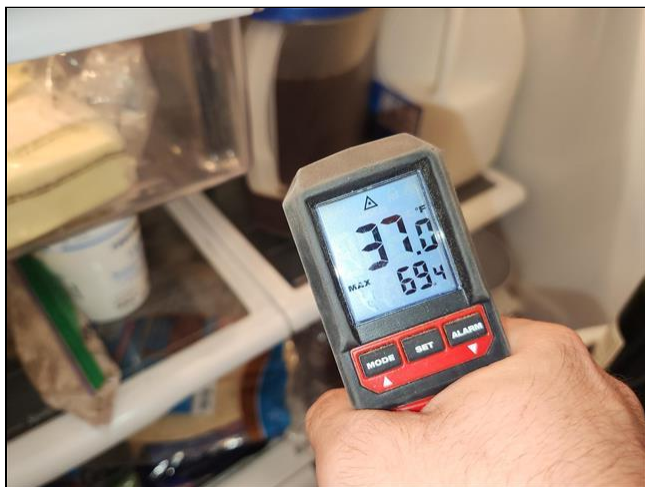
11.5 Item 1 (Picture)

11.5 Refrigerator: NOTE:

The refrigerator/freezer, freon levels, icemaker operation and other specialty items are beyond the scope of inspection. A temperature reading ONLY was taken for your information only. The refrigerator should be kept at or below 40 degrees fahrenheit and the freezer at or below 0 degrees. The refrigerator supplied temperature at 37 degrees and the freezer at 1 degrees.

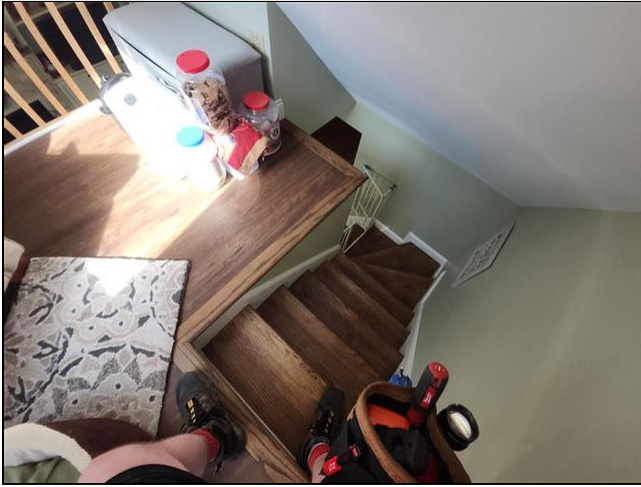
12.5 Item 1 (Picture)

12.5 (1) Stairways: Major Defect:

No railings noted at both basement and loft steps, recommend installing guardrails handrails for safety.

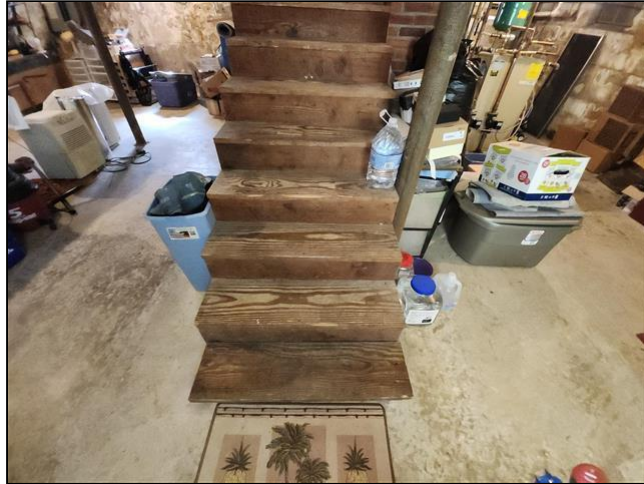
12.5 Item 4 (Picture)

12.5 (3) Stairways: Upgrade:

Risers for steps are uneven at basement steps. This is a possible trip hazard. Client may want to consider correcting to enhance safety.

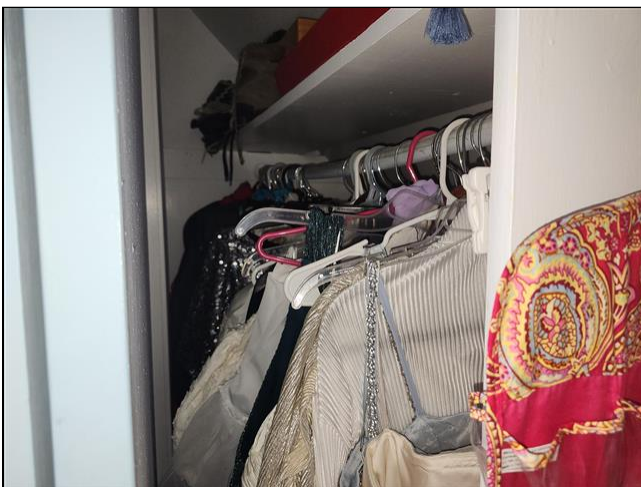
12.7 Item 2 (Picture)

12.7 (2) Interior Rooms and Areas Comments: Confirm:

Limited review at various locations due to personal property packing in progress stored items, shelving, and cluttered condition.

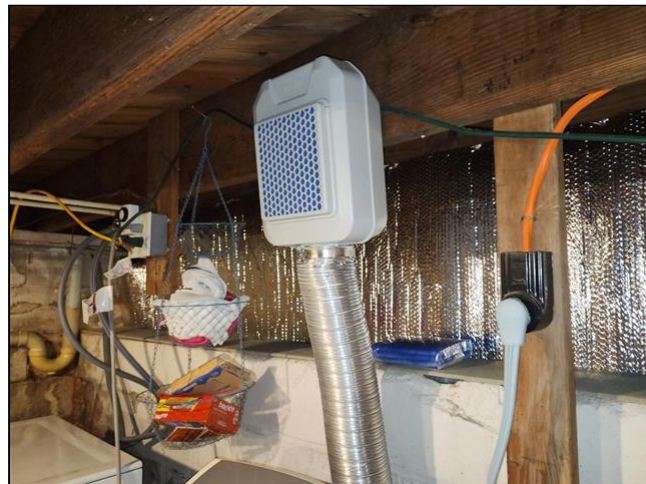
14.2 Item 1 (Picture)

14.2 (1) Dryer Vent: Upgrade:

Vent is ending in a filter exhaust.
Recommend running exhaust to the exterior to keep moisture/lint from accumulating in the basement.
